Forest Industry Safety Alert

Fire Extinguisher Maintenance

Location: North Campbell River

Date: March 1, 2017

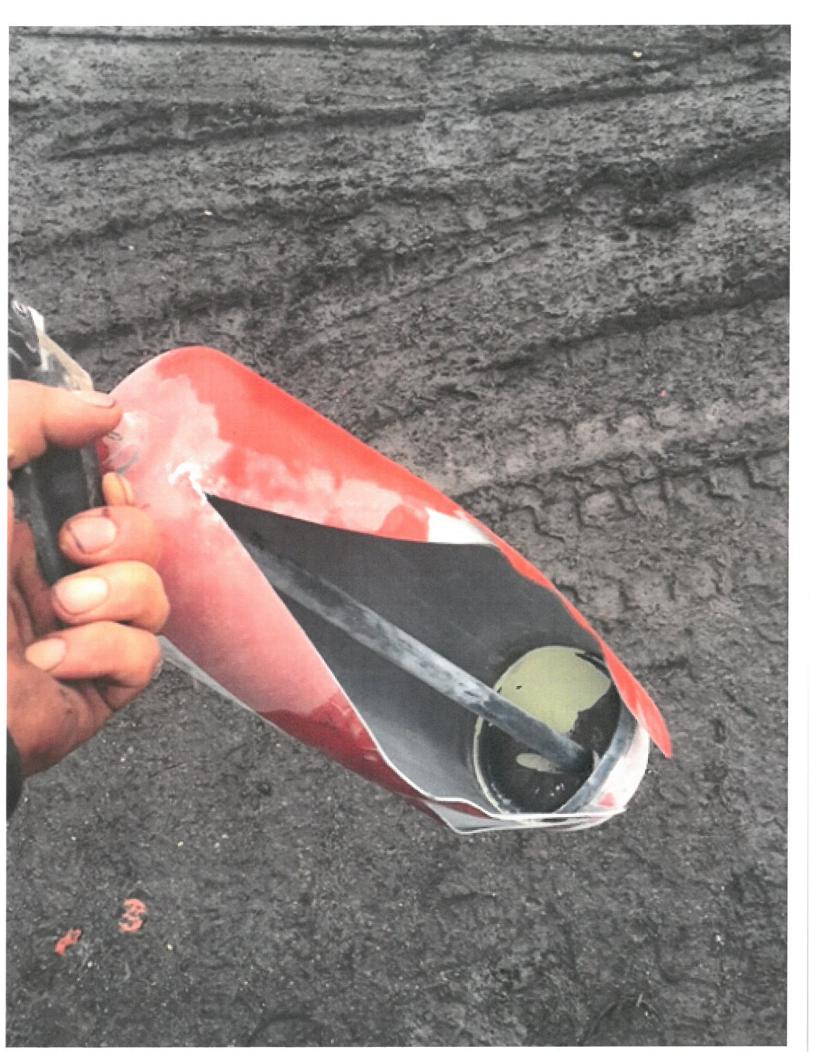
A mechanic was performing the regular maintenance inspection on a fire extinguisher at a dryland sort.

The gauge was checked and the needle was in the green zone. The date was marked on the tag and then the fire extinguisher was flipped over. In order to ensure the powder content had not settled and packed in the bottom, the mechanic tapped the bottom of the extinguisher with a rubber mallet.

The fire extinguisher exploded and shot the bottom end and the content 50 feet, narrowly missing the mechanic.

- Ensure that eye protection is worn and perform maintenance in a safe area to prevent injury to self and others.
- Check that the gauge needle is in the middle of the green zone.
- Ensure the pin and tamper seal are intact and nozzle has not been hindered in any way.
- Wipe clean the cylinder to remove any dirt or grease.
- Inspect the cylinder, there should be no dents, leaks, rust, chemical deposits and/or other signs of abuse or wear.
- If the extinguisher is damaged or needs recharging, replace it.
- Recharge all extinguishers immediately after use regardless of how much they were used.
- Shake the extinguisher or gently tap with a rubber mallet after thorough examination.
