SAFETY ALERT

May 2018

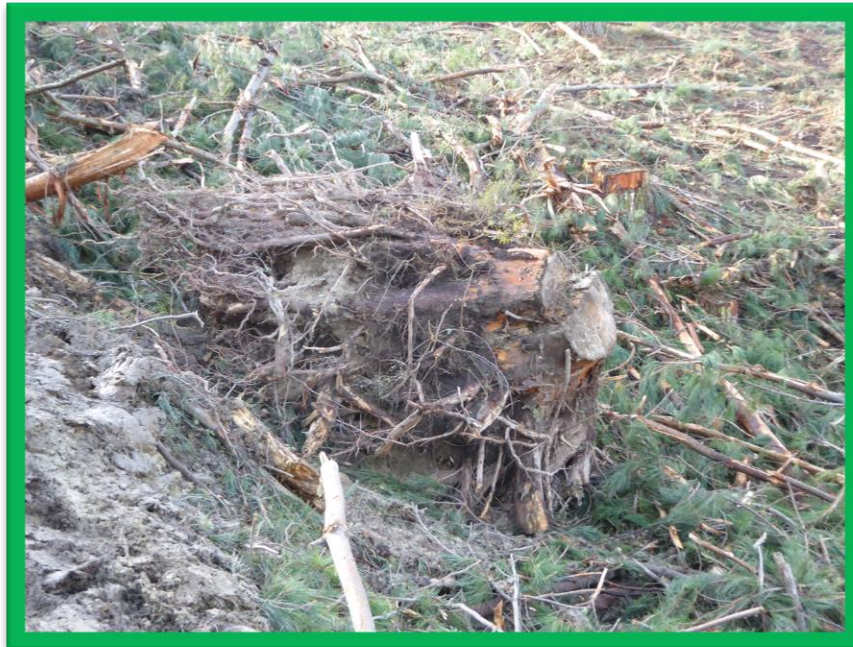
A worker breaking out for a road-line logging operation was almost hit by a tumbling root-ball. The above picture shows a typical root-ball extracted from the ground by an excavator clearing pilot tracks for a road-line logging crew.

The root-ball was extracted and placed in what was thought to be a safe location that would not allow the root-ball to roll down-slope. The near-miss incident coincided with a period of heavy rain.

- Heavy rain dislodged the root-ball.
- The tracking excavator operator misjudged the stability of the slash and soil holding the root-ball in place.

- Thanking the breaker-out for reporting the incident – it has been an opportunity to review the hazard control systems by the three companies involved.
- Reminding all earthworks contractors that extracting material which could later move, such as boulders and root-balls, must be done taking into account:
 - Changing weather conditions.
 - The legal responsibility for all workers to avoid creating a hazard for any other people on site, either in the current operation or in future operations (for example hauler breaker-outs and fallers who could be on site in 1-2 years after the roading is completed).
