MANUFACTURING SAFETY ALERT

Fractured/Laceration of Fingertip

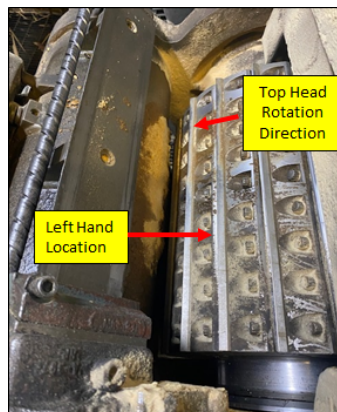
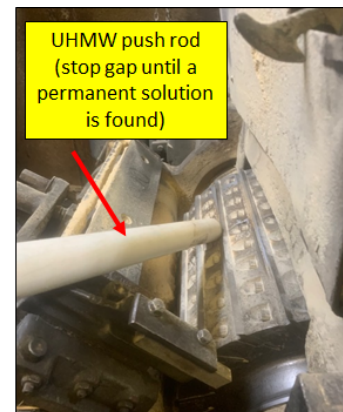
As part of the inspection, the crew member greased the top head to ensure it rotated freely. During this check, the top planer head got stuck. Wearing cut-resistant gloves, the crew member placed their left hand on the cutter head to rotate it forward and free it. The head turned abruptly, catching the crew member's left middle finger between the top head housing and a knife. This resulted in a laceration to the fingernail bed and a non-displaced fracture of the fingertip, requiring about 12 stitches.

- Increase observations of the Planer Set Up, Knife Change and Side Head processes to identify potential hazards and improvement opportunities.
- Contact vendors to discuss using safer tools or methods for changing and inspecting top, bottom and side cutter heads.
- Revise and update all Planer knife changing and Planer Set Up SWPs based on the investigation's findings, including vendor recommendations.

Always use a tool, never your hand, to rotate heads during inspections.
