MANUFACTURING SAFETY ALERT

VFD Failure/Fire

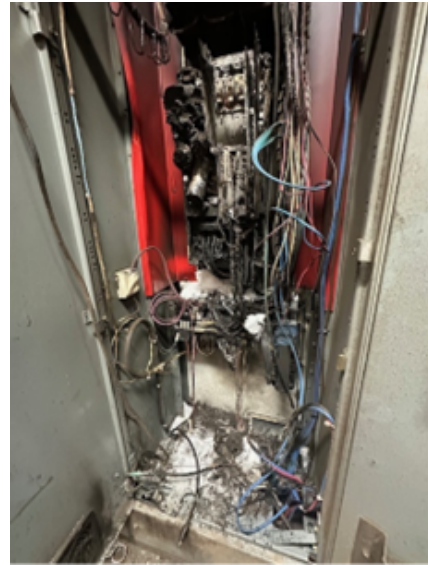
A ground fault on a debarker ring motor caused the variable frequency drive (VFD) to fail, leading to a fire in the motor control centre (MCC).

An investigation revealed that the grounding jumper was not removed from the VFD, allowing a higher ground fault current to flow through the drive instead of the neutral grounding resistor (NGR). This made the solidly connected VFD the path of least resistance, resulting in catastrophic failure due to the high fault current.

Fortunately, there were no injuries or significant equipment damage, except for the VFD enclosure.

- Confirm if MCCs are fed from well-grounded or resistive-grounded systems. Some divisions have both.
- Audit all VFDs to ensure they are configured according to OEM specifications for solid (jumpers inserted) or resistive-grounded systems (jumpers removed) and correct if not.

- Never assume the jumper positions when installing drives. Proper electrical installation of the drive is critical
- Jumper positions should be audited before installation and commissioning.
