MANUFACTURING SAFETY ALERT

Angle Grinder

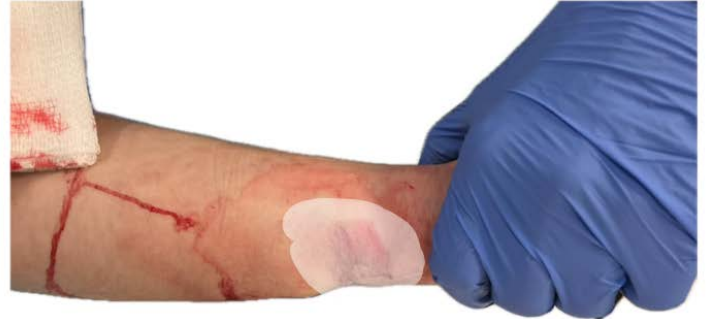
A welder was prepping a V groove root of a 23" pipe using an angle grinder with a feathering technique. The zip blade's flex rating allowed for light feathering instead of cutting if needed.

As the welder approached the bottom of the pipe, the grinder caught in the root, kicked back, and flew out of the welder's hand. The grinder bounced back with tremendous force, hitting the welder and causing a deep laceration and severing a tendon near the wrist, close to the radial artery.

Surgery was required on the tendon.

- Roll pipe to access bottom of root.
- Never grind on the backside of the wheel.
- Wear a Kevlar sleeve to protect from potential cuts.
- Keep guards in place, if you have to move it to perform an unsafe action, ask for assistance.
