SAFETY ALERT

Rock dislodges from log truck, penetrates windshield of oncoming pickup and strikes driver's arm

Date: March, 2025

Location: Highway 97N, between Prince George and Bear Lake

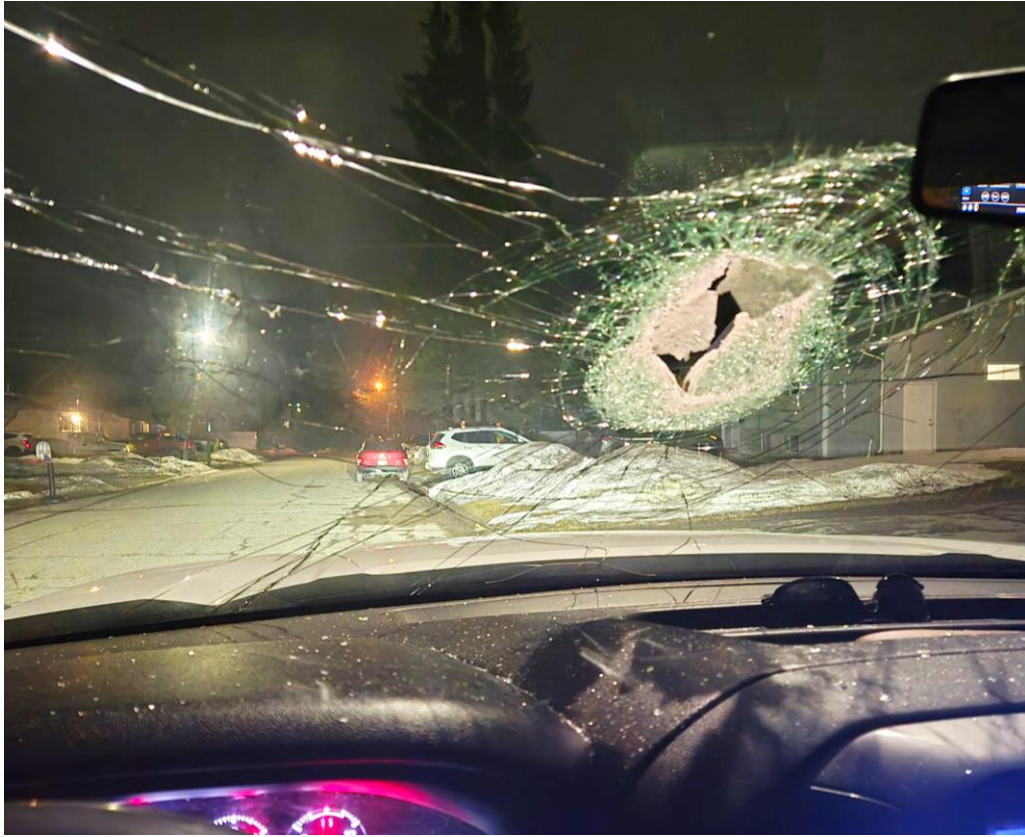
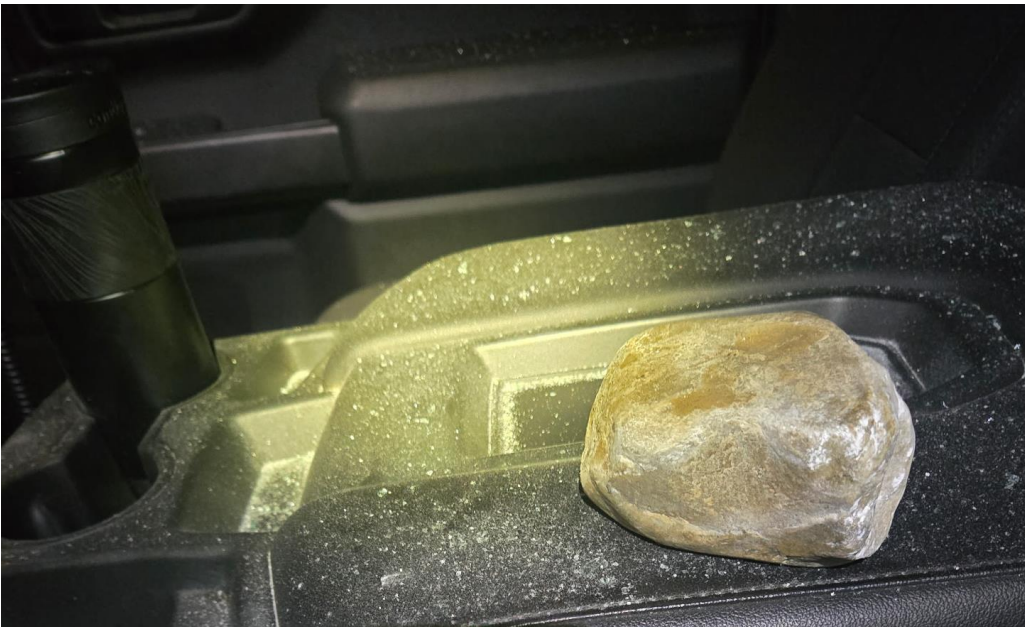
The first truck passed, and a rock came loose that impacted the pickup's windshield and entered the cab. The rock struck the pickup driver's arm, but fortunately no injury occurred. *See images on page 2.*

- Loader operators and log truck drivers have a responsibility to identify unsafe loads that could result in an incident in transit.
- Loader operators and truck drivers must ensure that all logs are stable within the bunk and that there are no embedded objects such as rocks/boulders that can fly off and cause damages.

- Ensure drivers have adequate light when inspecting their load at night.
- Look at all areas of the load, but also get down so you can see underneath and into the "belly" of the load.

- Look for rocks or other debris between all duals, particularly before entering public roads/highways.
- Check flat surfaces of your rigging (e.g. reach, frame rail, bunk / bolster) where a rock could be sitting, waiting to fall off. At 100 km/hr., a 7 cm (<3") rock can penetrate a windshield!

- Pay close attention when you have been travelling through muddy sections, or where you have spied rocks that are "just the right size" to get stuck between the tires.

- Check mud flaps and fenders to ensure they are in good working order.
