# Safety Alert of THE MONTH

March 2015

## Trailer Reach Separates on Loaded Log Truck

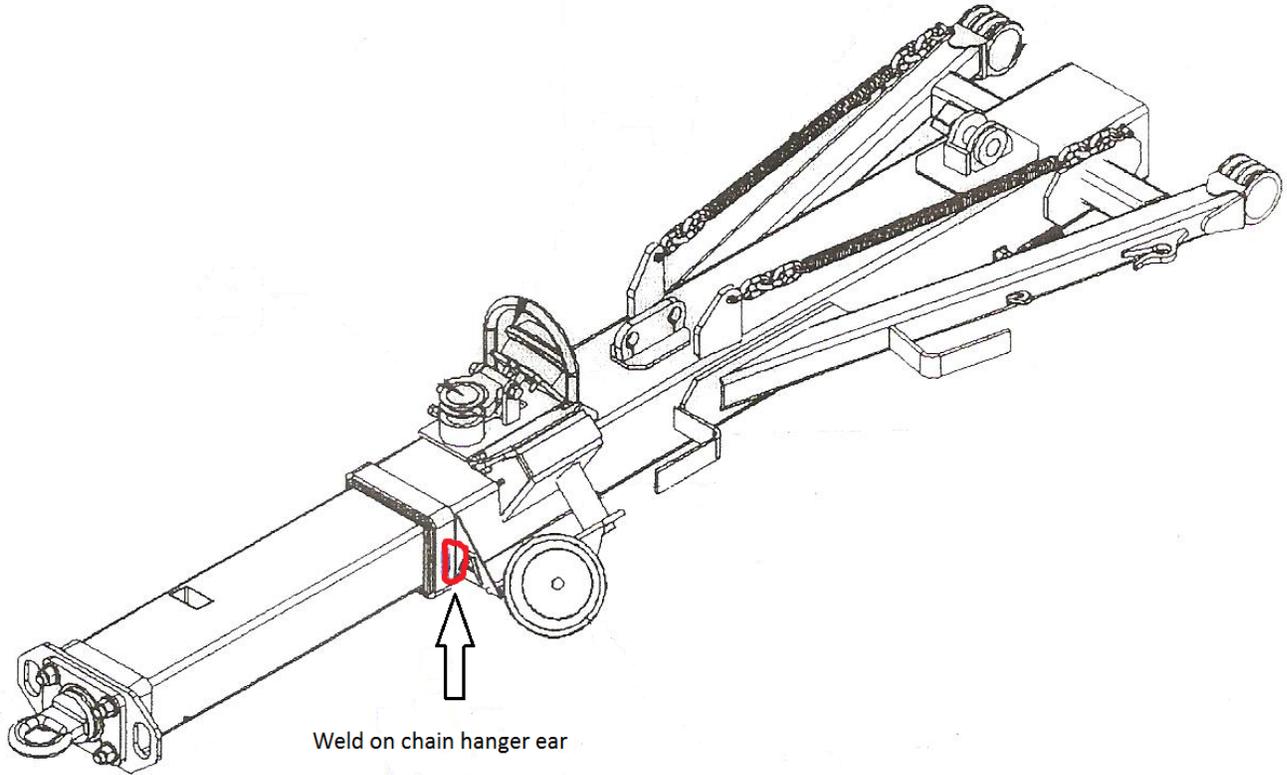
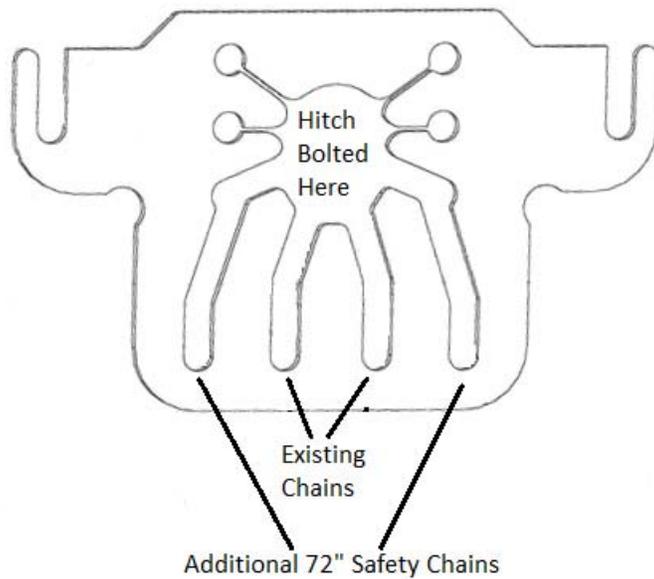
- Additional safety chains can be added to these trucks and trailers to provide extra security and help prevent these types of incidents. Two 72 inch safety chains (1/2 inch, Grade 70 chain) can be used to connect chain hanger ears to the existing safety chain hanger on the truck. These chain hanger ears are new components that are welded onto the trailer. See page 3 for diagrams.
