Arm Trapped in Felling Head during Repair

A machine operator's arm become trapped between the felling head's superstructure and the ram that controls the grapple fines. The accident occurred during a repair task. The injured worker was airlifted to hospital where he received treatment for compression injuries.

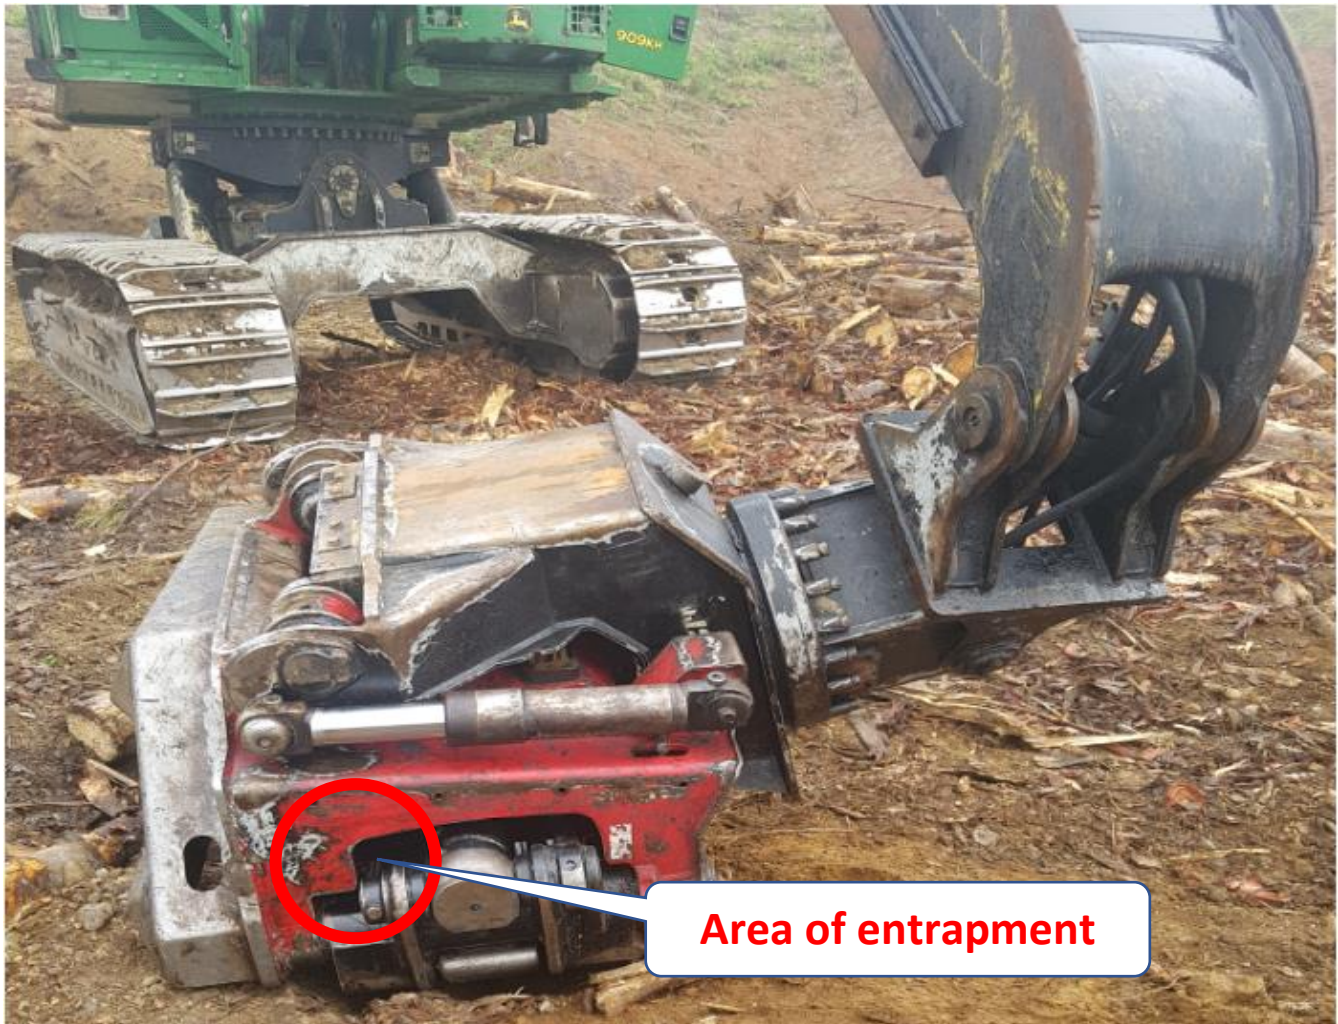
A small pin hole leak had been identified on a Waratah FL95 felling head ram responsible for the opening and closing the grapple. The machine was parked up for repair and a service provider called in to carry out the welding needed.

To repair (weld) the crack, hydraulic oil had to be removed from the ram. This required the hose connection to the ram valve bank to be released. The operator put his arm through a narrow gap at the grapple hinge point to loosen the connection. This released some but not all of the pressure and as the welding proceeded the ram began to weep oil. The repair was stopped and the operator put his arm back through the gap and released the residual pressure. This caused the grapple to open (creep) and trap his arm between the super structure and grapple ram. There may have also been some movement in the boom that contributed to the head's movement.

Compression on his arm involved approximately 25mm of closure movement and it took approximately 20 minutes to free him.

- The crew's Job Safety Analysis (JSA) for R&M wasn't followed. If it had, a different process would have been used (ie: Position the felling head in a safe and stable position before removing the valve bank cover and releasing any stored pressure. Then move the felling head to a suitable work position for the welding) – in other words the machine had been positioned to best suit the weld, not the hose removal

- The recommended isolation and tag out procedure was not followed (the harvester was isolated but not tagged out - the tag was in the harvester).
- The most experienced member of the crew was working on another machine at the time of the incident. He had been involved in the earlier induction of the service agent onto the site but not directing/overseeing the repair, as he normally would.

- Despite good production, prior breakdowns may have put perceived pressure on operator
- During the hose removal the machine's boom may have crept forward. This may have contributed to the rolling of the felling head and movement of the grapple arm.

- Always ensure those carrying out the task are familiar with and follow established safe practices for the repair or maintenance task at hand (includes crew procedures and the manufacturer's maintenance manuals).
- If there is insufficient guidance, ensure a risk assessment is carried out.
- High risk work must be adequately supervised, where skill or experience is still being developed.
- Where two or more people are undertaking an R&M task, agree on who is in charge.
- Ensure the boom is stable.
