## CLOSE CALL: Blasting

**Location:** Vancouver Island

**Date:** April 25, 2018

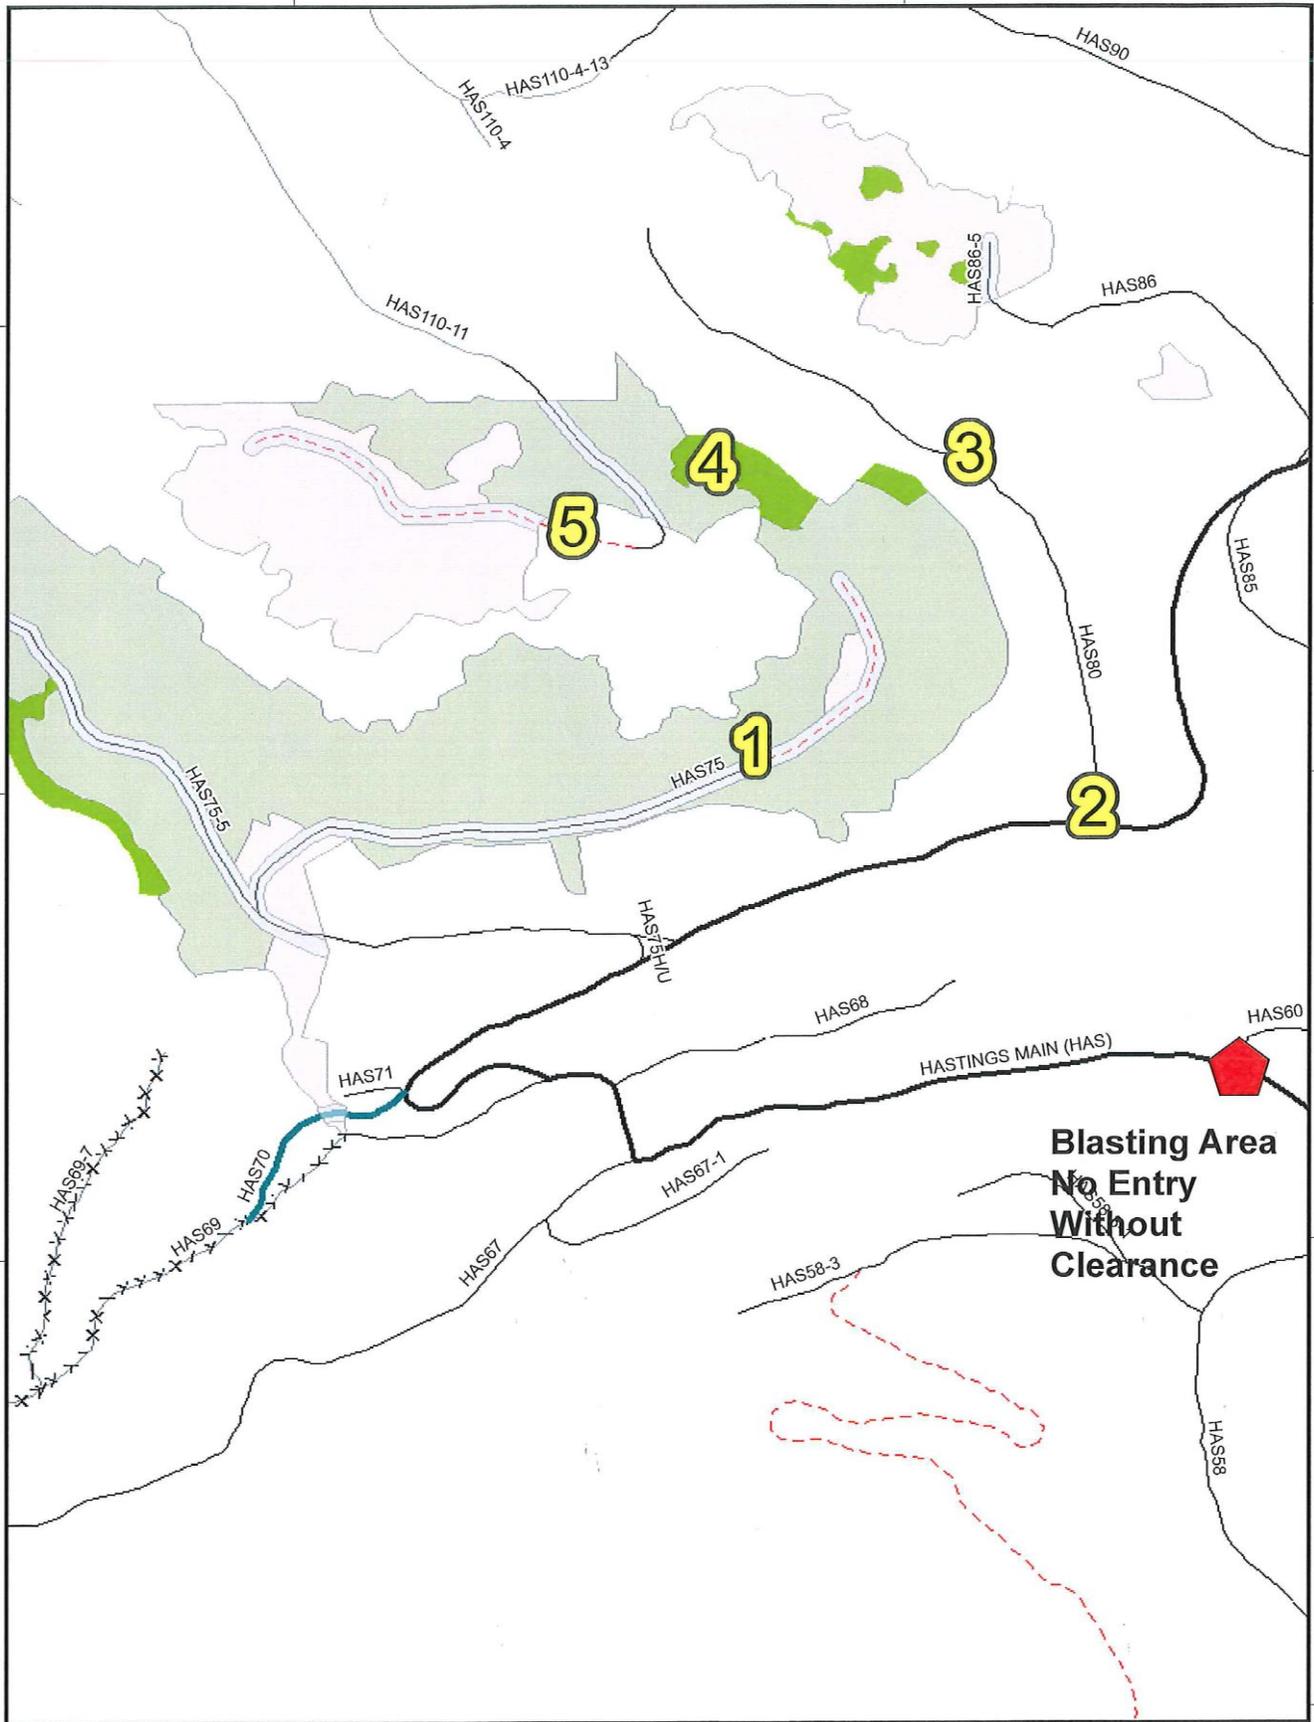
**Details of Close Call / Serious Incident / No injury:** The road construction lead operator (\*1) granted access to Forest Planners stopped at a “Blasting Area. No Entry Without Clearance” sign.

The Planner’s intention was to drive to 8km (\*2) on the mainline and then into a spur to park at (\*3), and then walk up into their work site (\*4).

The road construction lead assumed the Planners were working at 8km on the mainline, outside the blast danger zone. The Planners were given clearance and assumed they could work off the spur. The Planners were approximately 100 metres below the blast when the shot was detonated (\*5).

\*Note: refer to the map on the next page.

- The Blaster should ensure all spurs within the blast danger zone are checked, guarded and/or barricaded prior to initiating a blast.
- Forest workers planning to work in/near an active road construction area will meet (face-to-face) with the lead operator to develop a clear work and communication plan.
- Planners should use the most up-to-date mapping as part of their office / pre-work review.
