## HOE-FORWARDING INCIDENT

**Incident Date:** Feb 27, 2020    **Location:** Coastal Woodlands

**Incident Type:** Close Call    **Job Position:** Hoe-forwarding Operator

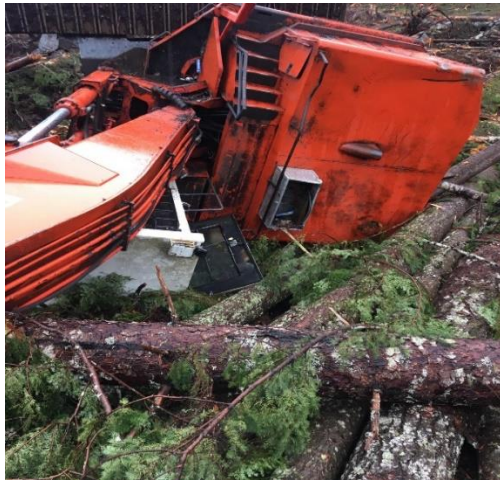
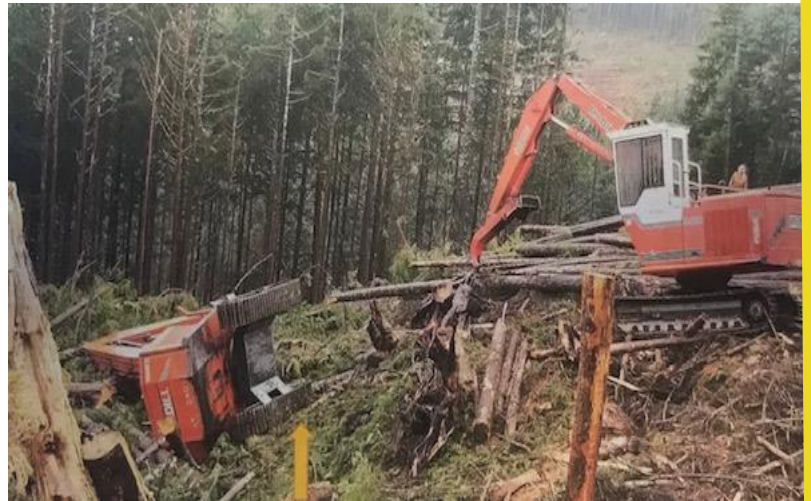
Madill 3800C was forwarding second growth logs downhill on 15% slope. Tracks were on a trail made of tops of logs and debris (puncheon). Boom was forward and down when the puncheon started to collapse. The back of tracks started to slide sideways, and the front of the left track came against a stump. Operator was unable to straighten the machine and it fell over, cab side down. Operator was wearing his seat belt and exited via rear door. Twenty mm of precipitation in the past 24hrs.

- Majority of hoe-forwarding incidents have occurred on relatively flat ground. Operators must not be complacent.
- Trails must support the machine and load with no large gaps or air/snow pockets.
- Soft/wet ground and other hazards must be tested before proceeding.
- Supervisors must regularly inspect/observe Machine Operators to ensure a good plan is in place and Operators are following safe work procedures.
- All Escape Hatches must be checked every shift to confirm easy egress with no obstructions.
- Review your past safety alerts and anchor the right safety practices in your business...Do not have repeats!
