# Forest Industry Safety Alert

## Saturated ground fails during road construction

**Location:** Crystal East FSR near Beaverdell, BC

**Date:** April 27, 2017

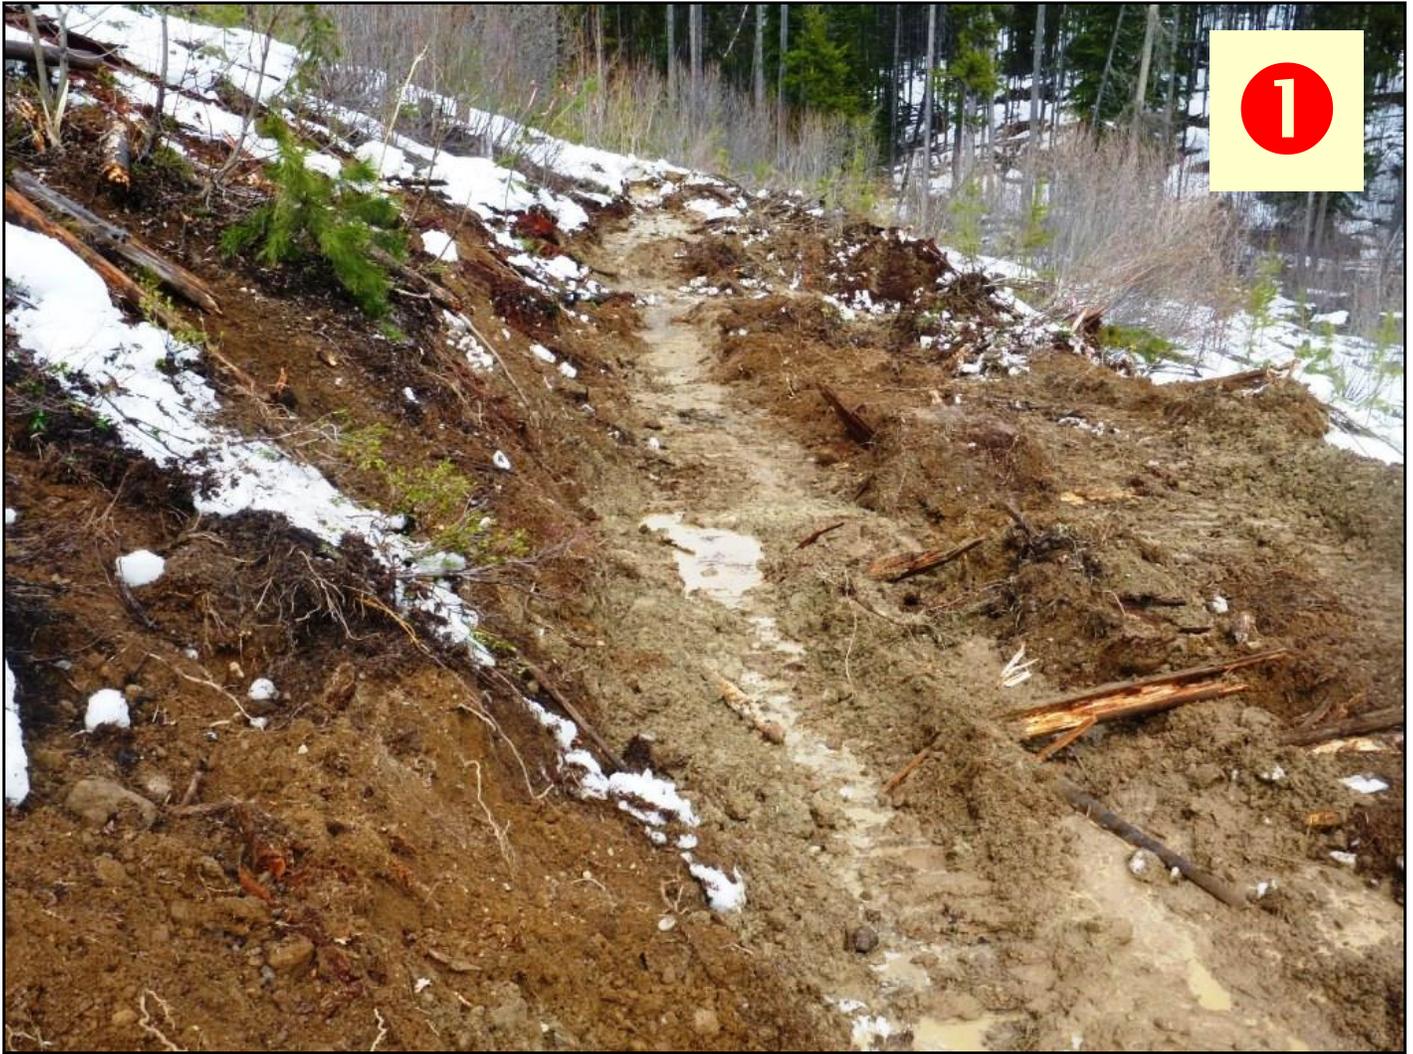
The hoe reached a point that the design identified as a three metre cut in solid rock which was down slope of a shallow-to-bedrock cleared area. It was observed by the operator that there was snowmelt flowing on exposed rock above the centerline.

Photo #1 shows the general conditions leading up to the bad spot.

1. The design cross sections indicated solid rock with a very shallow layer of overburden, but the soil was actually a deep pocket of saturated sandy loam. Soil types in cross sections are a “best guess” and can be very different than actual conditions. Always anticipate a surprise and be prepared for it by having a plan.

3. The area was very wet with melting snow and another spur just built had extreme muddy conditions. Determine what your limits are for constructing in adverse soil conditions and use wet weather shutdown criteria to know when to stop.

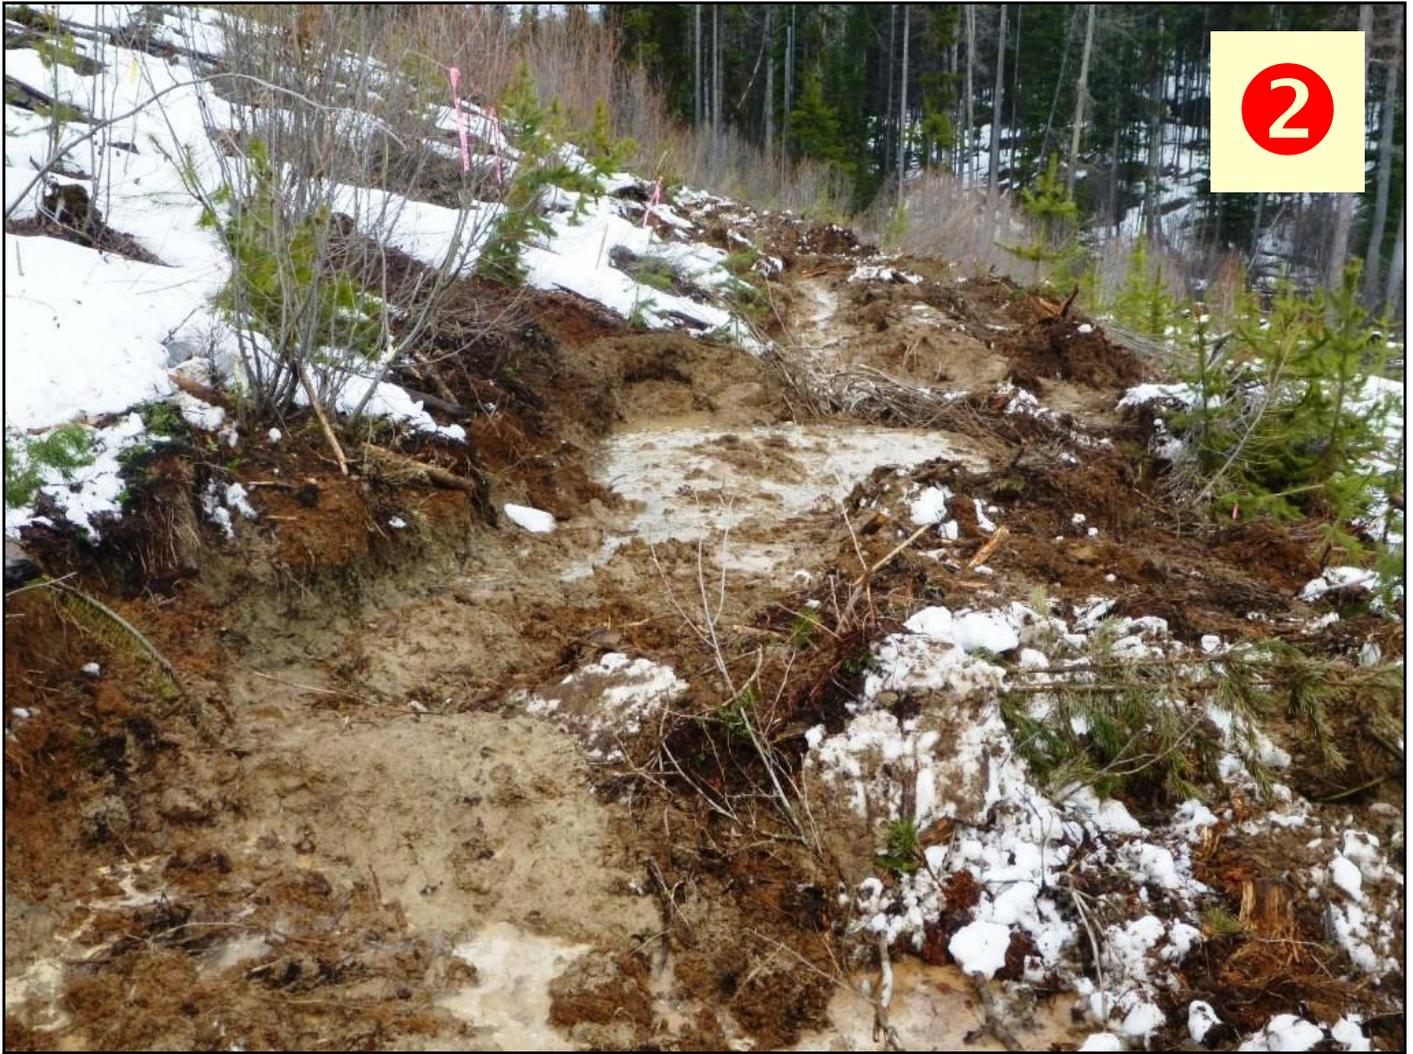
As the hoe travelled beneath the bedrock clearing, a deep pocket of soil suddenly gave way and the hoe began to slide below the centerline in a mass of liquefied soil. The operator, who is very experienced, immediately arrested the down slope movement using his bucket and constructed a rough water bar to channel the water flow away from the hoe. By pulling the hoe with the stick/bucket and installing several water bars, he was able to retreat back up the trail toward the starting point.

Photo #2 shows where the hoe starting sinking and sliding.

The soil was more liquid than solid.

All work was ceased and the project shut down until drier conditions prevailed. Had the operator not been able to arrest the downslope movement of the hoe, the machine could have slid about another 30 metres down the 30-40% slope to a saturated boggy site and become very stuck (see *photos of the ground conditions on pages 3 and 4*).
