Forest Industry Safety Alert

Log falls on truck driver at de-wrap station

Location: Northern Interior Region

Date: June 29, 2015

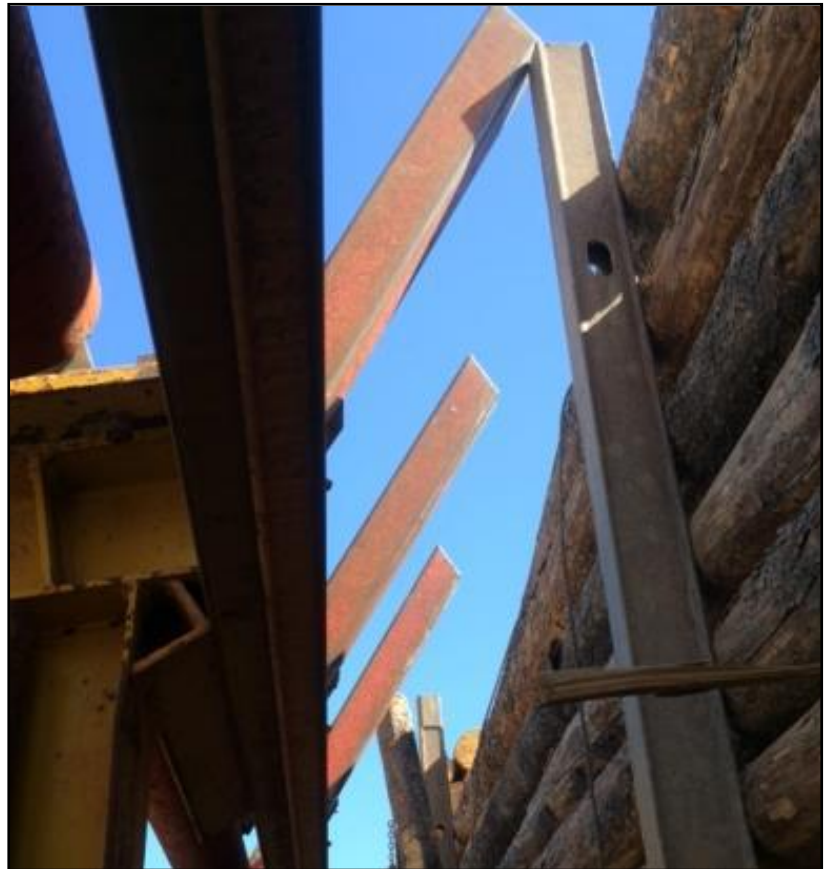
- The driver hadn't delivered to the log yard or used the particular de-wrap station in over a year.
- A shorter log was loaded on top of the load and not within the load, as per the log transportation procedures.
- The de-wrap station arms were resting against the trailer stake and not the load, which created room for the log to pass through and make contact with the driver (see photo).

- Log yard Supervisor will initiate more observations at the de-wrap station to ensure all safe work procedures are followed and equipment is used correctly.

- Contractor will review proper loading procedures with entire crew to ensure proper loading procedures are understood.
- Short logs must be contained within the bundle and not on top of the load.
- Drivers are responsible for the safety of the load before leaving the loader and before arriving at the scale.
- Incident will be reviewed with all drivers so they are aware of the risk associated when de-wrap arms are not resting against the load.
