# SAFETY ALERT

## Log Strikes Forwarder Cab - 24/1/2018

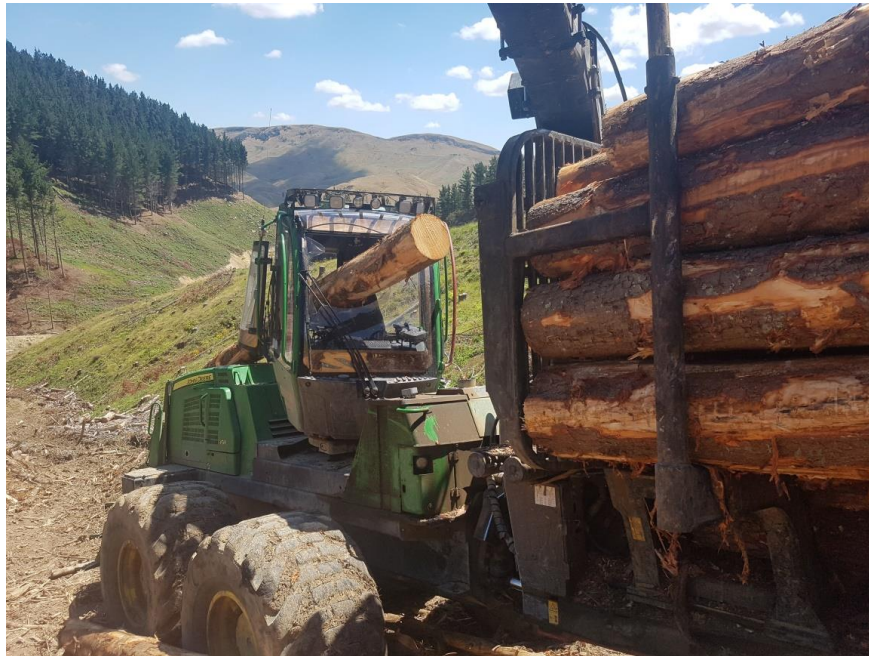
**What Happened?** Loading logs with forwarder grapple on steep country. Log on top of bunk was crossed up. The machine jerked while clearing the haul track, causing the log to slide over headboard hit windscreen and go right through the cab and out the back window, narrowly missing the operator.

**What was the main cause of the incident?** Crossed up log on top of load that slipped over the top of the cab guard

- Operator must take care loading logs, ensuring that all logs are located beneath cab guard
- Review harvesting system – i.e. shovel or grapple stems to a safer location to process and then forward logs to skid
- Cab window failed safety specification – it did not withstand impact of log. This needs reviewing/modification.
