Hazard Alert: Broken Excavator window

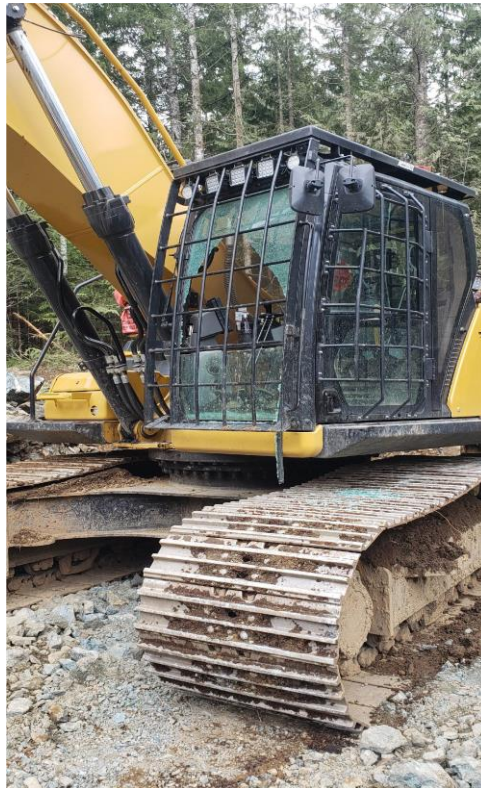
While loading a rock truck with shot rock, an excavator's front window shattered from a piece of broken shot rock. The shattered window showered the operator with broken glass.

- Some newer excavators are coming equipped with tempered front windows not safety glass.

- A window film made by 3M called Safe and Secure can be applied to the inside of a tempered windshield that will hold it together if it is broken.
