MANUFACTURING SAFETY ALERT

DESCRIPTION OF EVENT

Cut-By

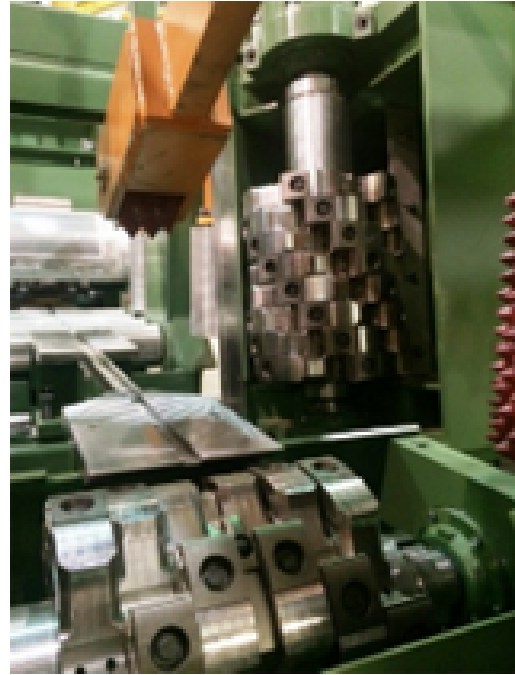
Picture from Optimil.com

While performing preventative maintenance (PM) work on a canter-quad chip head, a maintenance worker was attempting to attach a dial indicator to measure bearing deflection when they slipped on a narrow bed plate. The employee suffered a deep laceration on their left knee.

The incident happened on the second day of PM tasks. Safety procedures including a lockout verification and FLHA (Field Level Hazard Assessment) were properly conducted on the first day but only a lockout verification was completed on the second day. The new required FLHA was not completed.

- Before completing work around chipping heads or similar equipment, remove knives or cutting tools.
- Where knives cannot be removed, use covers to safeguard the blades to reduce cut-by hazards.
- All crew members should be reminded that when starting new tasks, if the scope of work changes or job tasks carry over into a new day, a reassessment of hazards and an FLHA must be completed.

Consider using covers on chipping heads to protect yourself during PM work.
