MANUFACTURING SAFETY ALERT

Hand Injury

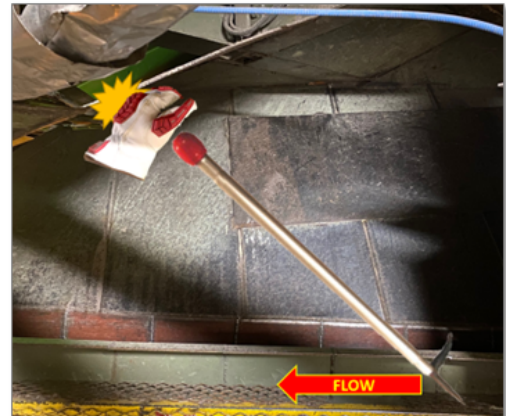
An employee was attempting to clear a jam in a waste conveyor using a three-foot pike pole.

They were working against the flow when debris from the tilt-hoist conveyor unexpectedly released, pressing against on the tip of the pike pole and pushing it into the waste conveyor.

The employee's left hand got wedged between the end of the pike pole and the upper part of the conveyor resulting in a severe laceration to the worker's left middle finger which required multiple stitches.

- Evaluate procedures and conduct a gap analysis for unjamming conveyors.
- Conduct a safety meeting to address identified gaps.
- Review correct techniques for unjamming conveyor procedures with relevant employees.
- Monitor operations regularly to ensure practices align with established procedures.
