# MANUFACTURING SAFETY ALERT

### Beam Trolley Damage

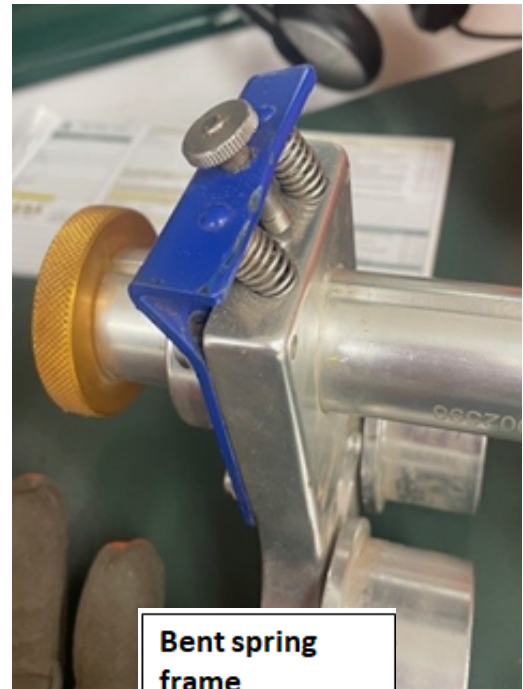
An electrician was tying off to a beam trolley when it fell off the beam and struck them on the top of their hard hat.

The quick-adjustable crane trolley was mounted on a crane rail and featured a retractable attachment.

The trolley was left on the crane rail, which was too high to reach. An incident investigation discovered the trolley was damaged during crane use.

- Do a site wide inventory of trolleys to ensure all quick adjustable trolleys are taken out of service.
- Review current crane tie off points, to see if non-crane tie offs can be installed.
- Have anchor points inspected annually.
- Investigate the option to install a physical stop between the crane and beam clamp to prevent damage to the anchor while moving the crane.

Do a site wide inventory of trolleys to ensure all quick adjustable trolleys are taken out of service and replaced by non-quick adjustable width trolleys.
