MANUFACTURING SAFETY ALERT

Hoisting Incident

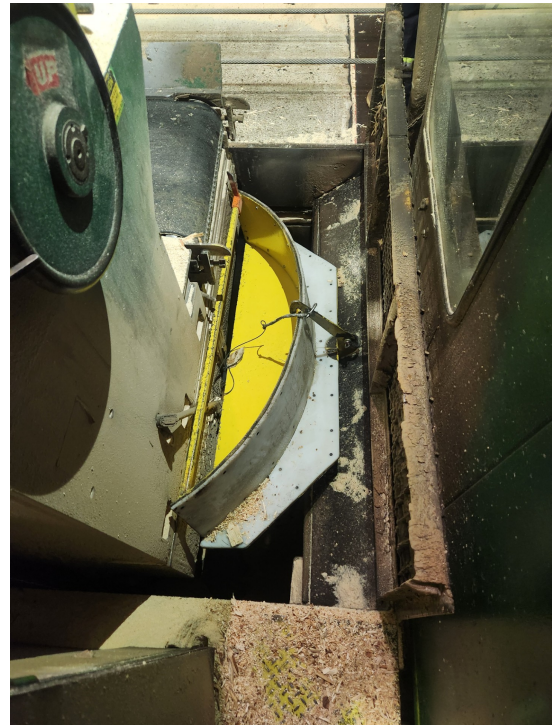
During routine maintenance, a sawfiler used a crane to lift a dull bandsaw to the filing room. As they lowered the cradle onto a handrail, slack developed in the crane cable, causing the hook to shift sideways and kink the cable.

Unaware of the kink, the operator opened the door and lifted the empty cradle above it to lower it into position.

The hook latch suddenly opened, and the 100lb cradle detached and fell 10 feet to the floor, missing a co-worker assisting with the task by just 7 feet.

- Install hooks that cannot detach from the cradle or crane cable.
- Organize a rigging course conducted by certified professionals.
- Review and revise all hoisting procedures.
- Ensure assisting workers stand on the far side of both carriage cables (approx. 12-15' away).

Provide refresher training for all hoist and crane users on pre-use inspection requirements and safe equipment use. Highlight this incident during training to demonstrate potential risks.
