# MANUFACTURING SAFETY ALERT

### Serious Hand Injury

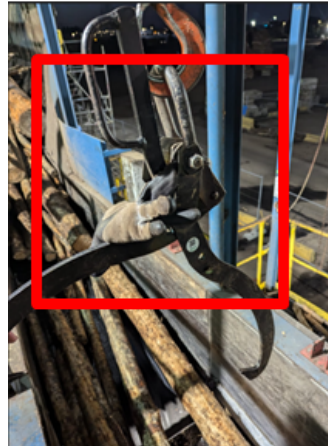
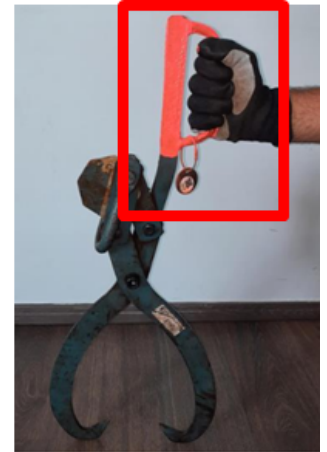
They placed their left hand in the hinge point of the wood clamp, instead of on the designated bracket. This led to the tip of the employee's left middle finger getting trapped between the tensioned hinge point causing amputation to the finger tip.

- Hold a Toolbox meeting to discuss incident.
- Inspect all wood clamps to ensure they have a hand bracket as illustrated.
- Review the SWP to ensure this type of equipment has documented SWPs.
- Spray wood clamp bracket in fluorescent orange.

Remind employees to keep their hands and fingers out of the bite.

Always use the provided safety brackets.
