MANUFACTURING SAFETY ALERT

Laceration and Fracture/Serious Injury

A lab technician suffered a serious injury while closing the lid on a steamer containing product samples for quality control.

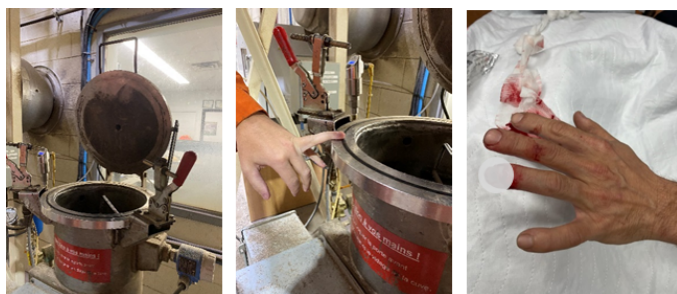
The heavy lid dropped on their left-hand ring finger causing a laceration that required three stitches and fracturing their fingertip.

- Share incident with all site workers.
- Install a small, retractable step at the front of the equipment more ergonomic and reachable access to the steamer lid for workers of all heights.
- Add a counterweight retention system for the lid.
