# SAFETY ALERT

## Snowplow Through Bay Door

**Date:** December 14, 2018

**Location:** Gilchrist

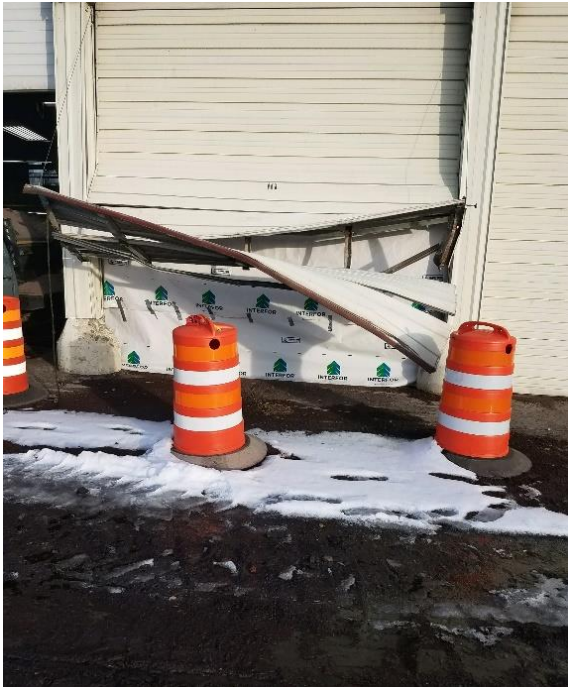
Vehicle was parked inside the truck shop with the bay doors closed. Employee opened door of the sander / snowplow truck and reached in and started the truck. The truck was in gear and lurched forward and went through the garage door. The truck traveled approximately three truck lengths before the employee was able to catch the truck and reach in and turn off the key.

- The clutch depression relay that requires that the clutch to be depressed in order to start the vehicle had been jumped and by-passed. It is not known when or by whom the relay was by-passed.
- A new harness has been ordered and installed by the mechanic.
- Employee was coached on the hazards of carbon monoxide poisoning.
- Employee was reinstructed on safe vehicle operation according to the JSA.
