SAFETY ALERT

Lost Time

November 11, 2017

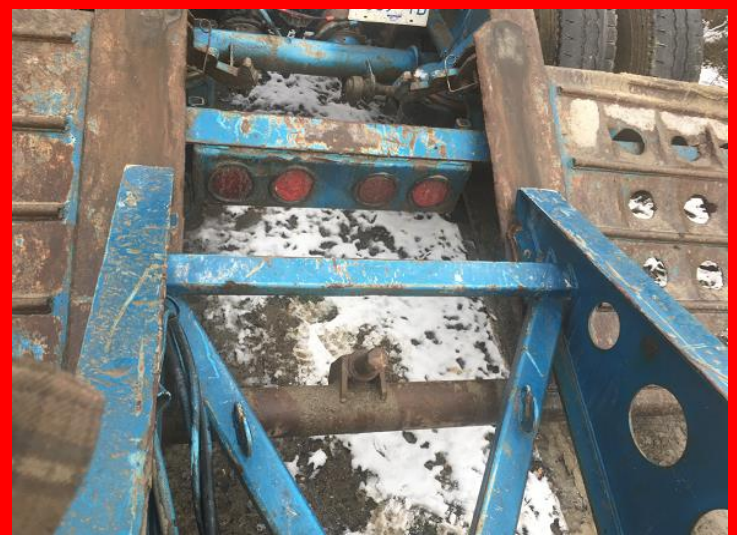
- Complacency, as typically the booster axle will only slide a short distance before coming to a stop when it comes in contact with the road.
- Not following the proper safe work procedures.
- Completing work on icy ground that was not flat.
- Standing in the “line of fire” or “bite”.

- A low bed operator attempted to disconnect the booster axle from the beavertail of a low bed trailer before disconnecting the air supply first.
- The ground was frozen and icy so the booster axle slipped off and slid a greater distance than normally is the case before coming to a complete stop.
- The operator's leg was fractured when it got “pinched” in between the booster axle and trailer.

- Review safe work procedures with all operators:
 - Only attempt to disconnect the booster axle on level ground.
 - Disconnect the air supply to the booster axle and ensure brakes have engaged before proceeding.
 - Caulk wheels on booster axle to ensure it cannot slide or roll away.
 - Disconnect the booster from the trailer.
 - When all clear, slowly pull the tractor trailer ahead allowing the booster axle to slide off.
 - Never stand in the “line of fire” and stay clear of the “bite”.
