August 14, 2018

Carrot Pin Bracket Strikes Public Vehicle On Highway

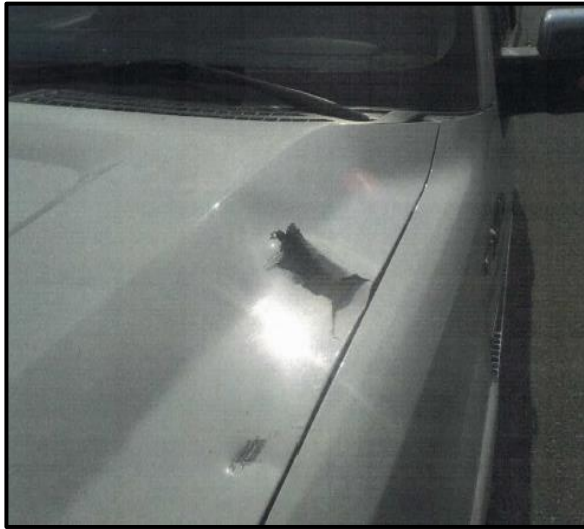
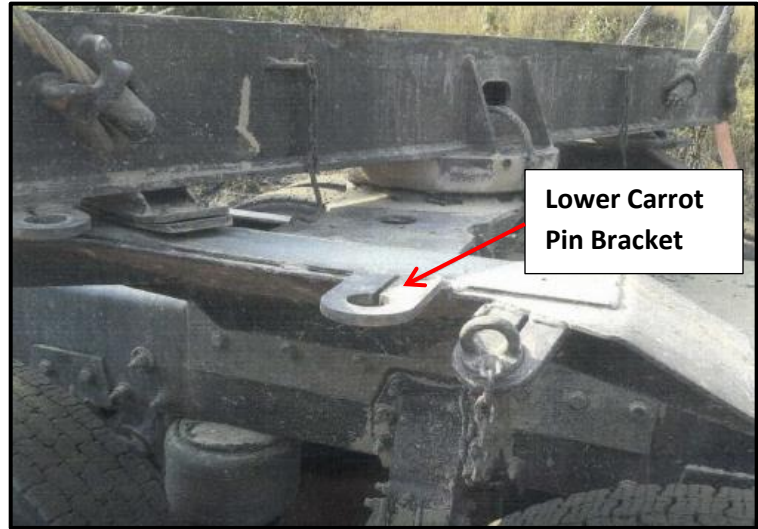
A logging truck driver heard the sound of a blown tire, and pulled over. While inspecting the tire, the driver of a public vehicle approached the logging truck to explain that a piece of metal had flown off the logging truck, and broke through the hood of the vehicle on the driver's side. Upon further investigation, the logging truck driver discovered that a carrot pin bracket was missing off the forward bunk.

- Remove the carrot pin from the bracket while the truck is loaded.
- Complete pre & post trip inspections on logging trucks, and correct identified issues.
- Schedule routine maintenance inspections to inspect all welds, including carrot pin welds.
