Reach Cable Fail

Summary:

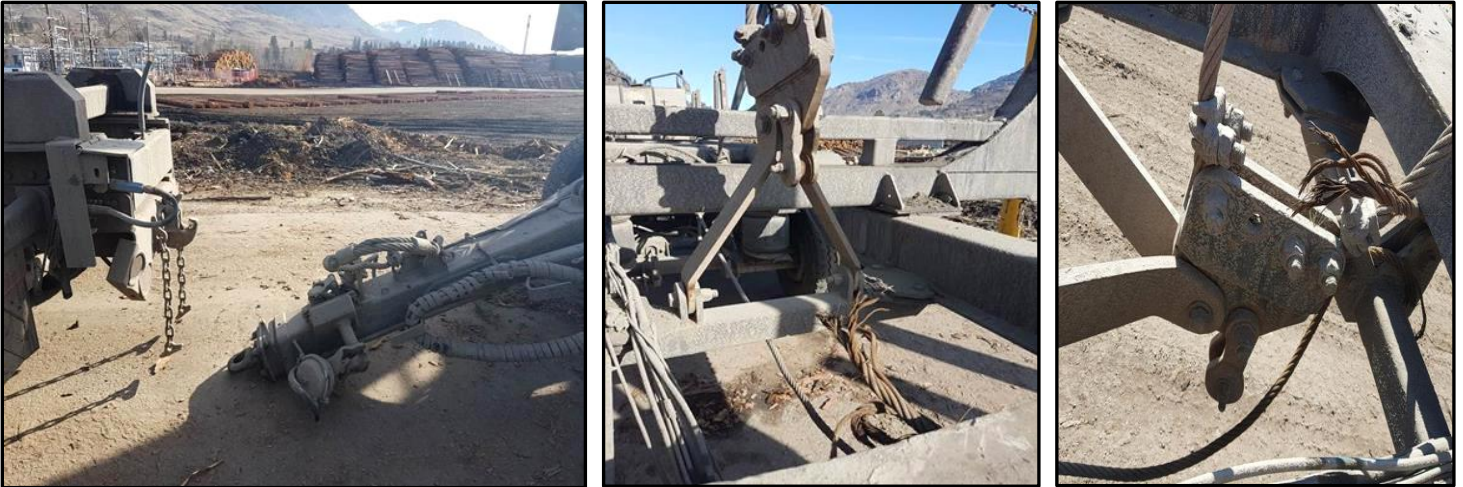
While attempting to load a trailer at a trailer hoist, the truck driver noticed the reach was not in position. The truck driver came out from the protective structure operating area to manually push the reach into position. While standing to the left of the reach, the reach cable failed, and the trailer reach struck the truck driver in the left wrist and leg before hitting the ground. The impact resulted in a fractured wrist and soft tissue damage to the leg.

- Do not put yourself 'in the bite'.
- Call for assistance when upset conditions occur.
- Complete pre & post trip inspections on logging trucks, and correct identified issues.
- Schedule routine maintenance tasks to replace worn cables.
- Do not leave the protected structure while trailers are elevated.
