SAFETY ALERT

Unloading Snowmobile Along Active Road

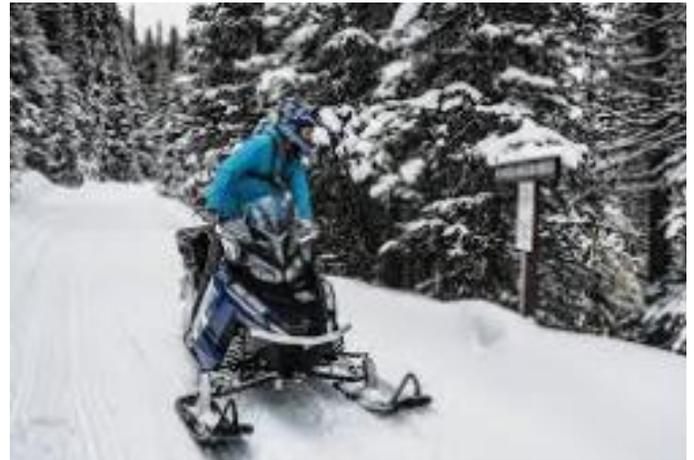
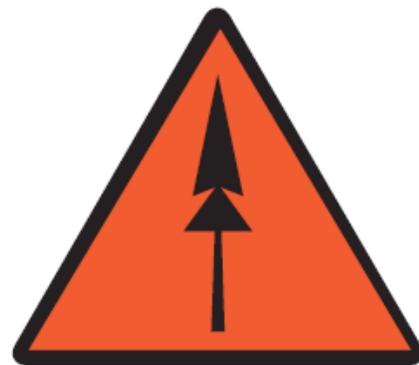
A layout crew parked in a small pullout along the mainline to unload their snow sleds. They called on the radio to let road traffic know they would be unloading sleds (at 88km) and to slow down and watch for them.

They had to back onto road to line up a straight approach to get over the large snowbank.

As they were reversing into the road, a loaded logging truck came at full speed around the corner.

Worker had large gloves on due to the extreme cold and couldn’t switch the sled out of reverse.

With only a few seconds to think, the worker jumped off the sled and out of the trucks path.

No impact occurred – it was a very serious near miss.

- Avoid unloading sled on active mainlines unless adequate sight lines or large enough pullouts.
- Coordinate plans with road maintenance to plow out additional pullouts and access roads to allow save place to unload sleds and turn around.
- Review block access prior to pre-work to ensure time to coordinate plowing out roads.
- Field staff should have a contingency plan in the event roads/pullouts have not been plowed and access is unsafe.
- Set-up “workers in area” sign to notify drivers of potential field crews on the roads.
- Dig out snow bank on an angle to the road so you don’t have to drive sled onto road to line up straight approach over bank.
- Use truck radio to communicate with drivers and not handheld.
