SAFETY ALERT

Equipment Hazards and Safe Operations

Date of Incident: January 9, 2019

Location: Coastal Woodlands

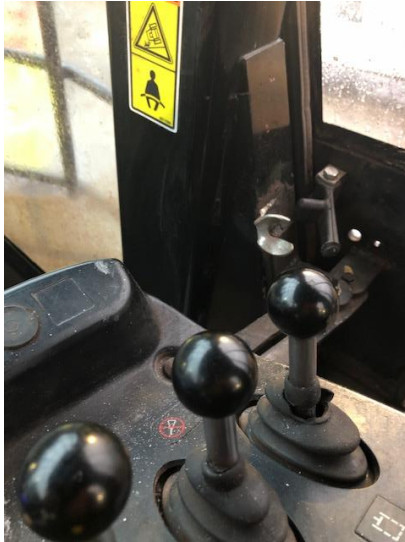
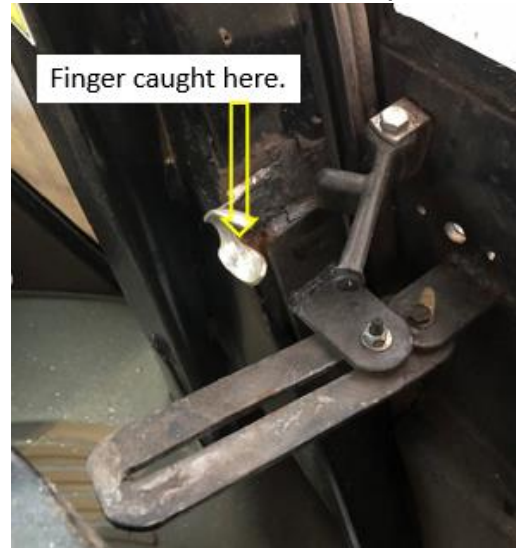
A Front End Loader Operator sustained a serious cut between fingers, requiring surgery.

- A Loader (966H) was travelling on a dry land sort carrying a very heavy load of 3 Hemlock logs (max load or overweight). Operator was wearing seat belt.
- The operator slowed and turned on the approach to a log bunk.
- Inertia caused front of machine to dip with grapple hitting pavement.
- The back end of loader lifted off the ground and the operator released a large log from the grapple. This caused the rear to abruptly drop.
- The loader violently shook and operator's hand flung approx 8 inches, catching finger in a metal latch (originally hood latch type, with after market change made).

- Equipment must be inspected and records kept for unsafe working conditions. This includes: sharp objects, guarding, escape hatches and other safety devices, hazards from modifications, ergonomics and maintenance issues.
- Manufacturer's specified payloads must not be exceeded and operators must travel at safe speeds. Extra time is required to stop when carrying loads.
- Supervisors must regularly observe equipment for care and control while logs are handled/moved.
- Unsafe equipment must be locked-out immediately with repairs done and/or hazards removed prior to operating.
