# SAFETY ALERT

## Trailer Loader

**Incident Date:** January 15, 2019

**Location:** Port Angeles

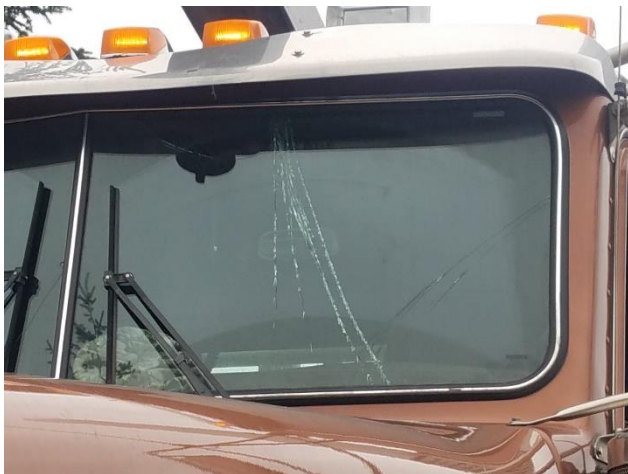
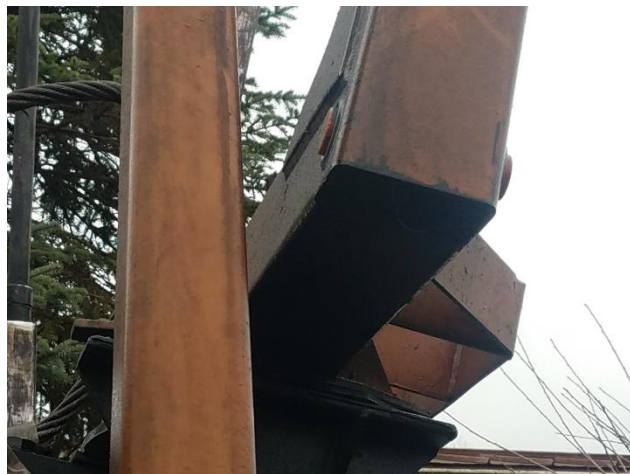
A truck driver was loading his trailer at the trailer loader. The current setup requires drivers to use foot pedals and a pike pole to maneuver the trailer into position. The trailer got hung up on the stakes causing the hitch to swing down and contact the cab; the driver was unable to stop this action as he could not remove his foot from the down switch before the damage occurred, in addition to the actuator intermittently sticking. Upon further investigation, there was mud buildup near the foot pedal actuator that was causing intermittent sticking. The driver was wearing appropriate hiking boots. The resulting damage was a broken windshield, broken fiberglass on cab and a bent deflector.

- All lifting equipment should be appropriately inspected and maintained.
- A monthly cleaning preventative maintenance (PM) will be created to ensure housekeeping standards are kept.
- The foot pedal toe cap will be raised by a ½ inch.
- Stay clear of the bite - never get under elevated loads.
