# Forest Industry Safety Alert

## Log loader cab penetrated by "hitchhiker" log; Window guard prevents injury to operator inside

**Location:** Southern Vancouver Island

**Date of Incident / Close Call:** April 29, 2014

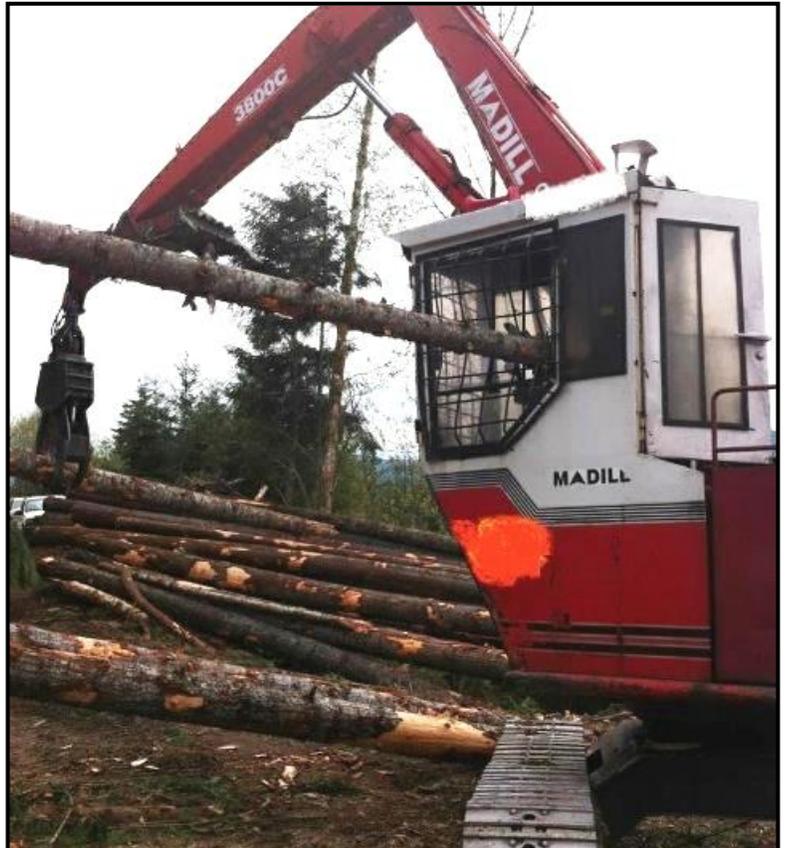
As the loader grappled a 24m (80') log and began to swing it around to position it for processing, a second "hitchhiker" log of equal size came along for the ride and struck the side of the cab. The operator was concentrating on the log in the grapple and failed to recognize the "hitchhiker" coming towards the loader.

The log penetrated the cab window making contact with operator's seat, as well as the operators left side ribs before being stopped by the cab window guarding. Fortunately the operator was uninjured.

- Review loading Safe Work Procedures (SWP's) and ensure loading from decks is thoroughly covered.
- Operators need to assess the whole deck before commencing operations, particularly where it's difficult to see the back of the deck.
- Recognize that yarding full length timber downhill and top first tends to increase the slope of log decks.
- Assess for changing conditions – (sap running may have been a contributing factor).
- Equipment positioning is critical even in the simplest situations – never be complacent.
- Be aware of the importance of cab guarding being in proper order.
