# Safety Alert OF THE MONTH

February 2019

## Landslide Risks for Forestry Operations

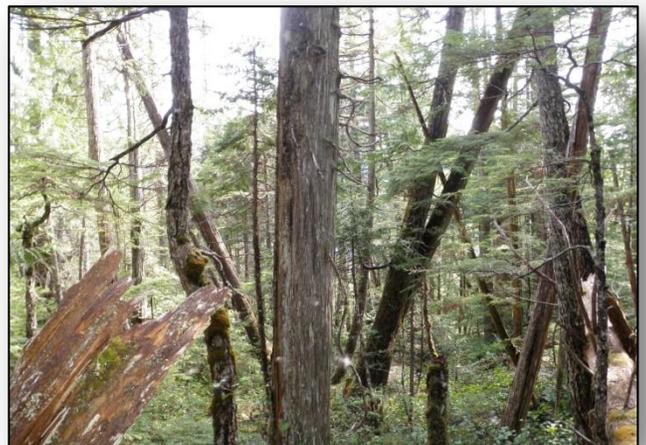
Jack-strawed trees

- New road construction operations on moderate to steep slopes can also create a risk of causing landslides. Site indicators to be aware of include wet organic soils particularly when over smooth bedrock and pistol butt or jack-strawed trees.

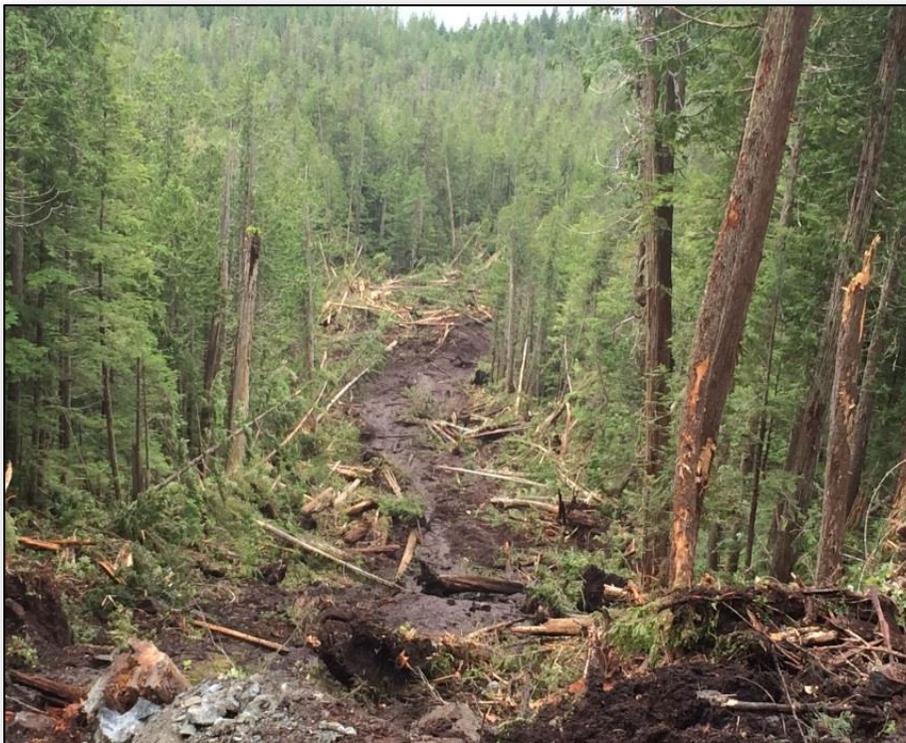
Example of landslide caused during road construction
