MANUFACTURING SAFETY ALERT

Railroad Crossing - Potential Multiple Fatality

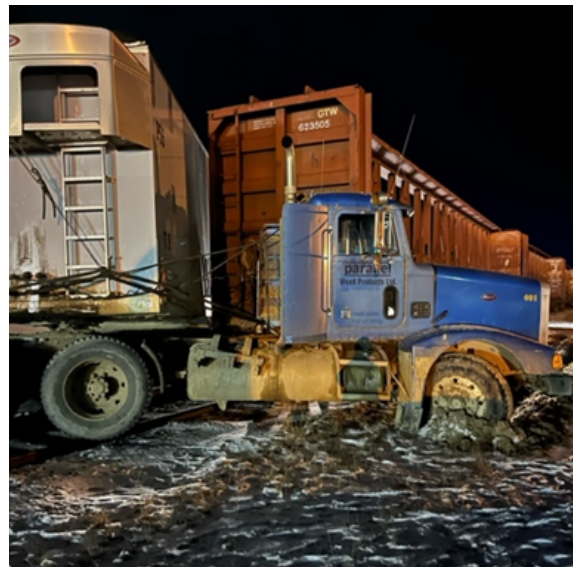
An empty truck and trailer were crossing the railway track approaching the mill location when the CN Train pushing 16 empty cars struck the truck trying to make it across the crossing.

It was dark and the driver did not notice the train coming or the conductor on the end of the cars.

The conductor was standing on the left side, his view was obstructed by the end of the cars. The conductor jumped on the inside of the rail car to protect him from the impact.

The driver nor the conductor were injured, however they could have both lost their lives.

- Add lighting to the railroad crossing to make it easier to see approaching train traffic.
- Ensure all traffic stops at the **STOP** sign to ensure no rail cars are coming. Cross the tracks in low gear and do not change gears while crossing.
- Clear brush- or cut back banks to allow for more visibility. Include areas with potential blind spots in yard inspections to ensure overgrowth does not obstruct the view of oncoming traffic/ trains.
- Ensure complete stop is made prior to crossing a railway crossing.
