# CHAG SAFETY ALERT

## Steep Road Incident

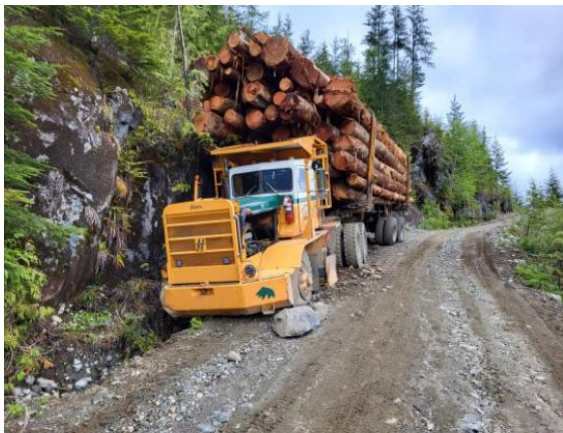
- A loaded off highway logging truck descended a 28% grade switchback.
- The road surface was damp.
- The driver applied the brakes and the trailer wheels were locking up and skidding.
- The truck was in 1<sup>st</sup> gear, travelling approximately 10 kilometers per hour. The driver released the Jake brake and eased off the trailer brakes.
- The truck started gaining speed, so the driver decided to drive the truck into the ditch. The truck hit a rock bluff (red dot in picture on the right).
- The driver sustained a minor concussion.

- Switchback with a steep slope (28% grade).
- Wet road conditions.

- Complete a steep road assessment.
- Monitor road conditions.
- Perform daily truck and trailer inspections.
- Perform tug tests with a loaded and unloaded trailer.
- Check brake function prior to descending sections of steep road.
