MANUFACTURING SAFETY ALERT

Electrical Pole Fire

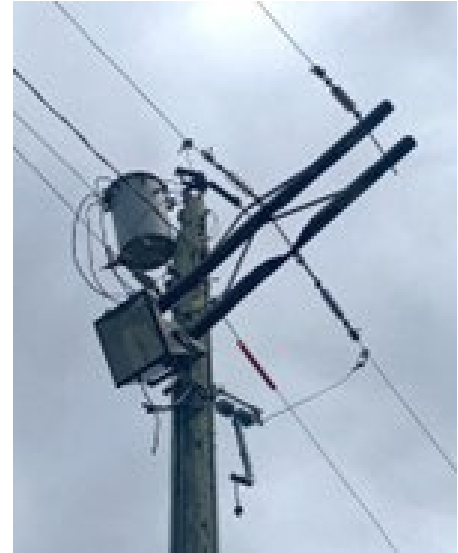
A site tenant reported a fire at the top of an electrical pole. Both BC Hydro and the fire department were notified.

The discovery of nesting material suggests it may have been the cause of the fire.

- Conduct regular inspections of overhead power distribution networks to identify potential hazards.
- Clear away vegetation near and around power poles and remove trees at risk of falling. Inspect poles for deterioration every five years to prevent collapse.
- Install dedicated poles 2m higher than surrounding ones equipped with platforms for nesting birds. And/or use spike mats and angled deflectors on the cross arms to deter birds from building nests.
