# MANUFACTURING SAFETY ALERT

### Potential Energy

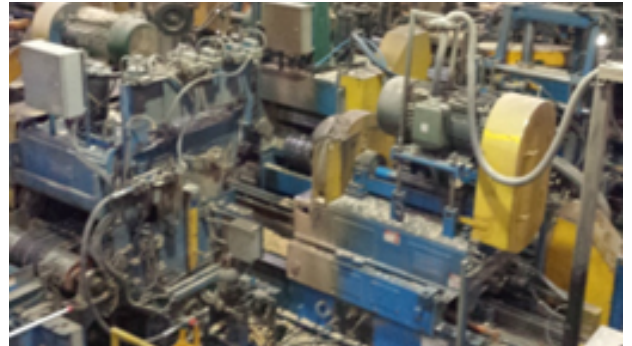
It was discovered that a blockage in the dump valve was causing it to open slower than normal leading to prolonged pressurization in the line.

- Always perform a lockout and verification test your before starting the work.
- Make sure all hydraulic systems are completely depressurized before working on them.
- If a lockout test fails, investigate the system/process to determine why it failed and implement safety procedures to confirm it is safe to resume or proceed with the work.
