PROMOTING SAFETY IN THE WORKPLACE

LOCKOUT ZONE SAFETY CURTAINS

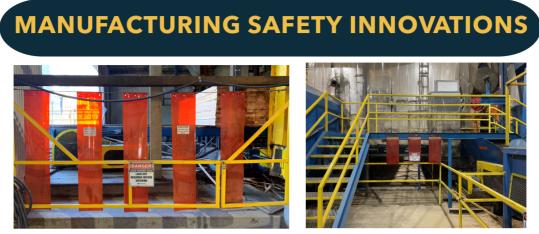
The safety committee proposed a simple, cost-effective solution to maintain secure restricted lockout zones while allowing safe worker access. They recommended customizable red PVC strip curtains as hazard indicators when barriers are removed. These LOCKOUT ZONE SAFETYCURTAINS ensure safe and unrestricted access during lockout tasks.

During maintenance and cleanup, restricted areas are often locked out and opened for access, introducing hidden hazards and risks of inadvertent entry by other personnel. Installing <u>LOCKOUT ZONESAFETY</u> <u>CURTAINS</u>, will identify the boundaries of restricted areas without compromising safe access for those working inside the area.
