INDUSTRY SAFETY ALERT

Feller Buncher, Hoe Chucker Tip Over on Steep Slopes

Date: October, November 2024

Locations: Scotch Creek, BC and Sugar Lake, BC

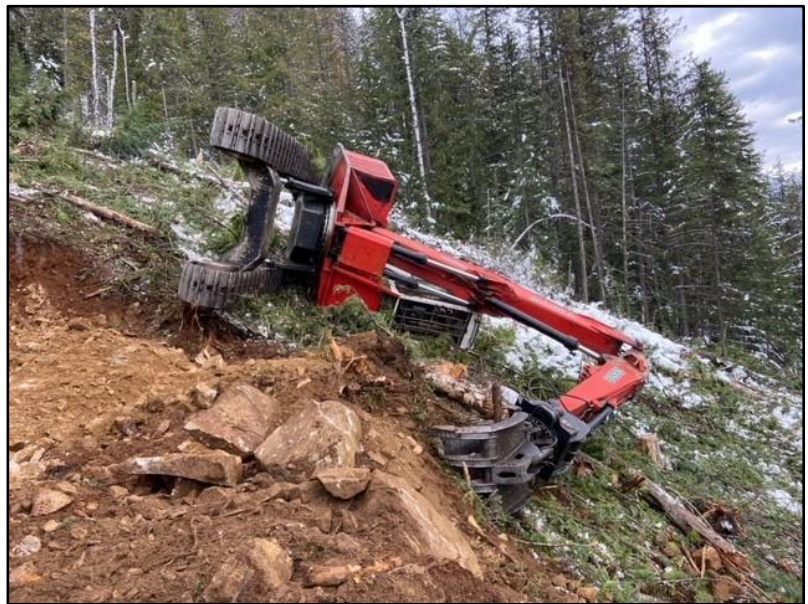
Hoe Chucker Incident: While chucking timber on a steep slope (55-60%), one of the machine’s tracks slipped on shallow rock concealed by the topsoil.

This caused the other track to catch on a stump, turning the machine before it tipped over onto

its side. The machine was walking down the slope on the same path it had travelled without incident going up the hill.

In both incidents, the machine operators were fortunately not injured and the machines essentially undamaged.

- Steep slope plans are to be completed for each block and should be site-specific for the block that the equipment is working in.
- Build and use trails if required on steep slopes.

- If available, a tether/winch should be used while working on steep slopes.
- Situational awareness: Focus on not only what's in front, but all current surroundings.

- Complacency? The operators had done this work before and may have developed a false sense of security and confidence.
- Fatigue? These incidents occurred later in the week after working long days out of camp.

- During mobile equipment inspections ensure there are no loose objects in the operator's cab (i.e. - toolbox, hand tools, lunchbox, thermos, etc.). Carefully look at seat belts, guarding, cab protection and escape hatches.

- Emergency Response Plans (ERPs) and drills should include equipment rollover incidents which can be very challenging in remote and less accessible locations.
