INDUSTRY SAFETY ALERT

Hoe Chucker Tip Over

Date: November 2024

Location: Sugar Lake, BC

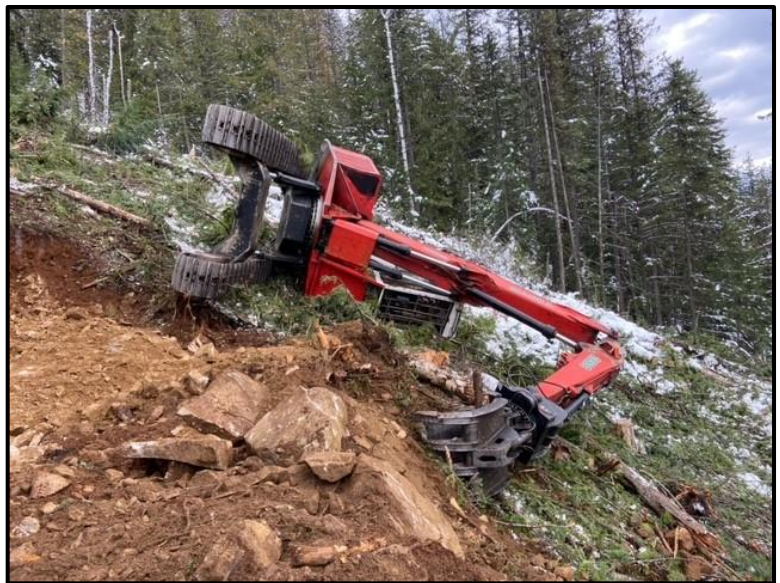
Details: While hoe chucking timber on a steep slope (55-60%), one of the machine's tracks slipped on shallow rock concealed by the topsoil.

This caused the other track to catch on a stump, turning the machine before it tipped over onto its side. The machine was walking down the slope on the same path it had travelled without incident going up the hill.

The worker was uninjured and the machine undamaged.

- Steep slope plans are to be completed for each block and should be site-specific for the block that the equipment is working in.
- Build and use trails if required on steep slopes.

- The tether for this machine was not in use at the time. If available, a tether/winch should be used while working on steep slopes.
- Complacency? The operator has done this work before, and may have developed a false sense of security and confidence.

- Fatigue? The incident happened later in the week after working long days out of camp.
- During the mobile equipment inspection ensure there are no loose objects in the cab of equipment (i.e. - toolbox, hand tools, lunchbox, thermos, etc.) Look at seat belts, guarding, cab protection and escape hatches.

- Emergency Response Plans (ERPs) and drills should include equipment rollover incidents which can be very challenging in remote and less accessible locations.
