MANUFACTURING SAFETY ALERT

Arc Flash

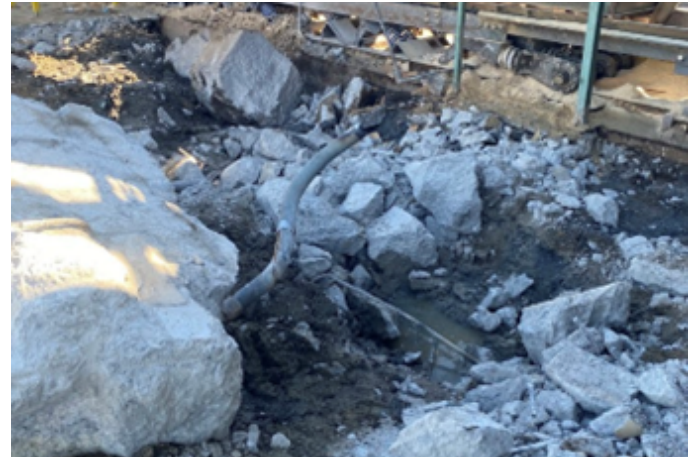
While removing concrete from a project area with an excavator, a contractor accidentally struck a buried electrical conduit and rebar causing an arc flash at the breaker cabinet and transformer.

Fortunately, no injuries occurred. Work was suspended to investigate and establish new safety protocols and expectations.

The contractor's safety policy was revised to prohibit work near energized or pressurized underground lines/pipes until a safe work plan was put in place.

- Establish a "no-go zone" around energized lines per utility guidelines (e.g., OSHA's approach limits). Ensure all personnel and machinery stay well outside the zone.
- Coordinate with utility providers to de-energize services near demolition activities when possible.
- Require mill team approval for all high-hazard (Red JHA) contractor work before work begins.

Before digging, locate, identify and clearly mark all utilities. Prioritize de-energizing systems, rerouting wiring and marking hazardous areas before work begins.

If pipe locations are unknown, use hand digging or hydro excavating to prevent pipe damage.
