MANUFACTURING SAFETY ALERT

Thermal Oil - Fire

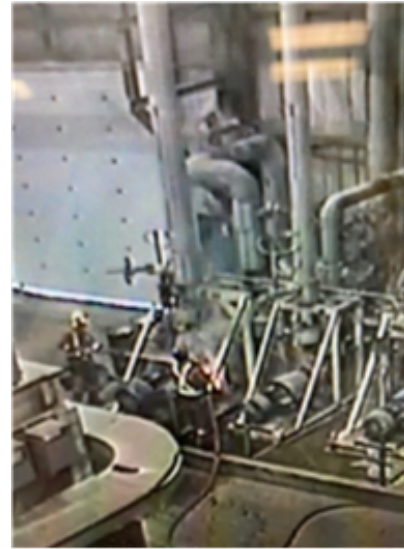
After a hot alignment, a thermal oil pump caught fire upon restart. The pump had been running normally, but the restart was deferred to ensure qualified personnel were available for monitoring.

Minutes after restarting, an open flame developed, which the standby crew quickly extinguished.

This mechanical failure did not result in oil containment loss. The pump was a newly rebuilt, non-OEM ((Original Equipment Manufacturer) unit, as the original was obsolete. As a precaution, since the pump was a rebuild, a foam cart and standby personnel were readied for fire suppression.

- Prioritize safety over production when planning.
- Carefully monitor rebuilt or non-OEM thermal oil components.
- Use OEM equipment and parts whenever possible.
- Enhance quality assurance/control programs to prevent new equipment failures. programs to avoid new equipment failures.
